| Subject:<br><br>EXTERIOR LIGHT WARNING WITH DTC B10A3:86 | Bulletin No.: 09-011/26 |
| | Last Issued : 02/25/2026 |

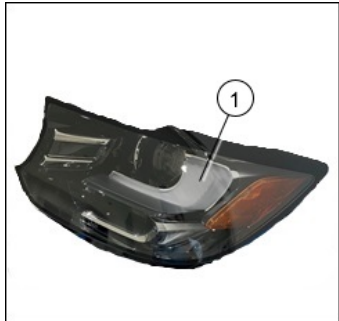
Exterior light warning light

Some vehicles equipped with the Adaptive Front lighting System (AFS) may exhibit the exterior light warning light/ exterior light warning indication on while driving or when the ignition is turned on and DTC B10A3:86 (Error signal received from swivel actuator (LH)) stored in memory.

2. Reprogram the **AFS** with the Mazda Modular Diagnostic System (M-MDS), using Mazda Diagnostic And Repair Software (MDARS). Refer to MDARS ECU Reprogramming Procedure.

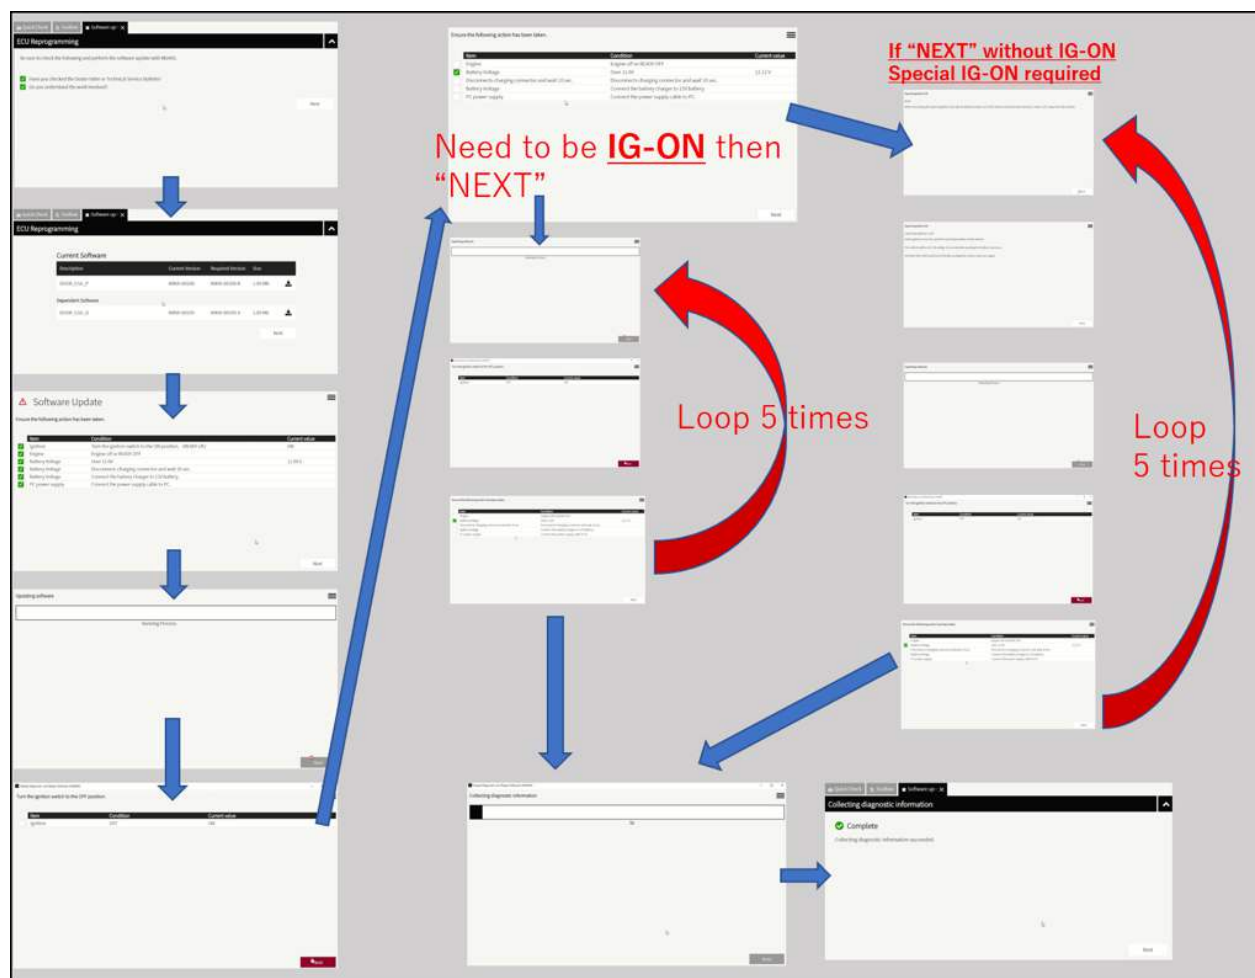
**CAUTION:** MDARS reprogramming may require looping IG-ON 5 times.
