# Service Bulletin

Bulletin No.: PIP5927D

**Subject: Diagnostic Tips: Possible DTC P0237 P0101 P1101 P0234 or P0299 Reduced Engine Power**

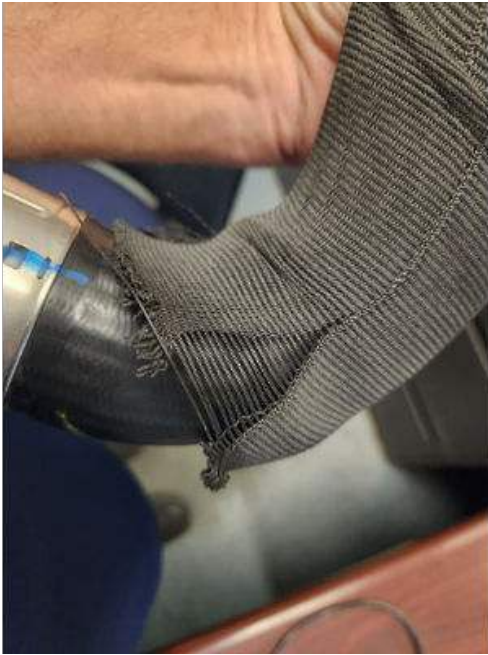
#1

This type of damage would allow the hose to swell under pressure damaging the abrasion sleeve and altering the readings within the boost control system or create a potential air leak.

Pictures below show damage to abrasion sleeve on Charge Air Inlet Hose.

Replace Charge Air Inlet Pipe assembly using latest parts listed in EPC.

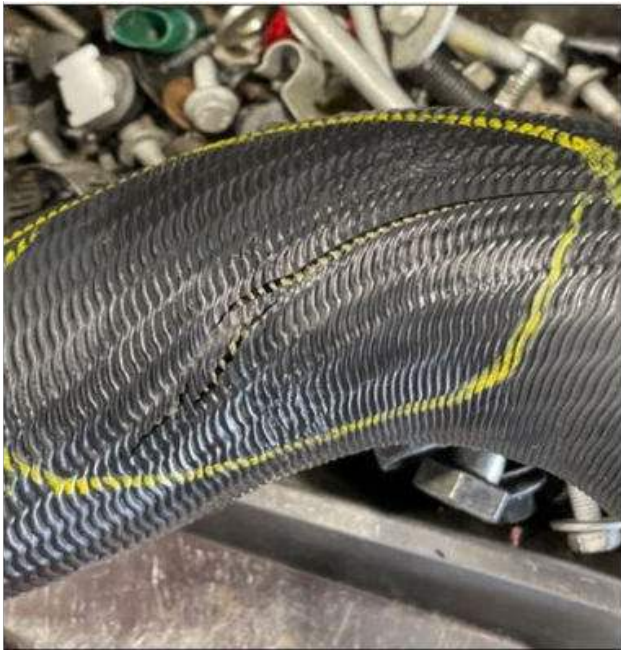
#3 Picture below inside the circled area shows damage to inner hose beneath abrasion sleeve
