## Condition

| Model(s) | Year(s) | VIN Range | Vehicle Specific Equipment |
|---|---|---|---|
| Q3 | 2021 – 2025 | All | Not applicable |

All part and service references provided in this TSB (**2072305**) are subject to change and/or removal. Always check with your Parts Department and/or ETKA for the latest information and parts bulletins. Please check the Repair Manual for fasteners, bolts, nuts, and screws that require replacement during the repair.

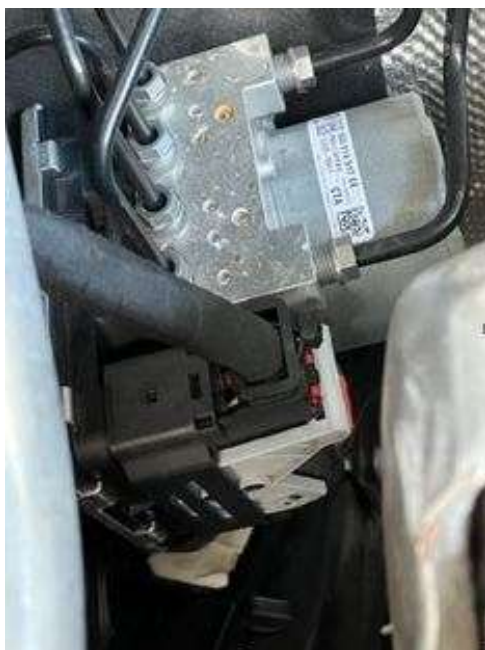
The analyses have shown that the vacuum pump fuse was blown due to the connector of the ABS control unit being improperly disconnected. The improper separation of the ABS connector and the subsequent running of the engine / driving operations meant that the vacuum pump exceeded certain internal parameters. As a result, the vacuum pump fuse blows and the vacuum pump itself can become irreparably damaged / can fail.

**Figure 1:** ABS hydraulic unit / ABS control unit connector.

- Take pictures of the ABS control unit/ABS control unit connector and upload to DOC-IT.
- Check if the connector has been unplugged from the ABS control unit, or if there are any signs of tampering (e.g., scratches on the connector).
- If the connector has been unplugged from the ABS control unit or if tampering has been determined, the repair cannot be billed under warranty.
- Replace triggered / blown vacuum pump fuses according to *ELSA>>Repair Manual>>Electrical System>>Electrical Equipment>>97 Wiring>>Relay Panels, Fuse Panels and E-Box>>Component Location Overview*.
- Check if the vacuum pump works and runs properly as per *ELSA>>Repair Manual>>Chassis>>Brake System>>47 Hydraulic Components>>Vacuum System>>Overview Vacuum Pump*.

- **If the connector has been unplugged from the ABS control unit or if tampering has been determined, the repair cannot be billed under warranty.**
- **If the connector has not been unplugged from the ABS control unit and no tampering has been determined, this TSB does not apply!**
