## Condition

| Model(s) | Year(s) | VIN Range | Vehicle Specific Equipment |
|---|---|---|---|
| A6 Sportback e-tron, S6 Sportback e-tron, Q6 e-tron, Q6 Sportback e-tron, SQ6 e-tron, and SQ6 Sportback e-tron | 2025 | All | Not applicable |

All part and service references provided in this TSB (**2077962**) are subject to change and/or removal. Always check with your Parts Department and/or ETKA for the latest information and parts bulletins. Please check the Repair Manual for fasteners, bolts, nuts, and screws that require replacement during the repair.

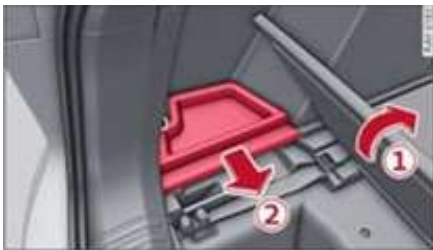
**Figure 1:** Fuse carrier installation location: luggage compartment on left, open cover.

Remove fuse F39 (activation of charging flap and charging socket no.1) or F43 (activation of charging flap and charging socket no.2) for at least 10 seconds. The fuse is located in the luggage compartment (see following images).

Reinsert the fuse in its position.

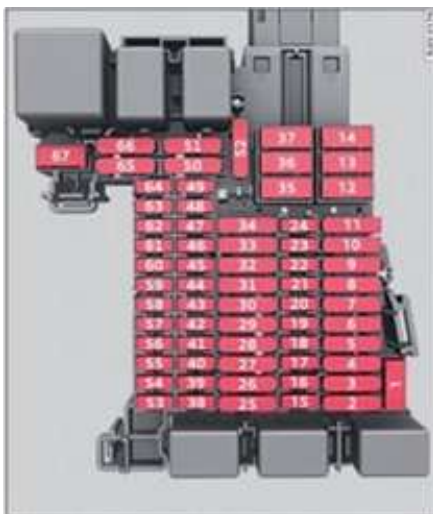
**Figure 2:** Fuse carrier.
