| Model(s) | Year(s) | VIN Range | Vehicle Specific Equipment |
|---|---|---|---|
| A5, S5 (FU), Q5, Q5 Sportback, SQ5, and SQ5 Sportback (FU) | 2025 – 2026 | All | Not applicable |

This PSS replaces TSB 2079757, 90 PPE/PPC: warning messages about assist systems - U171200

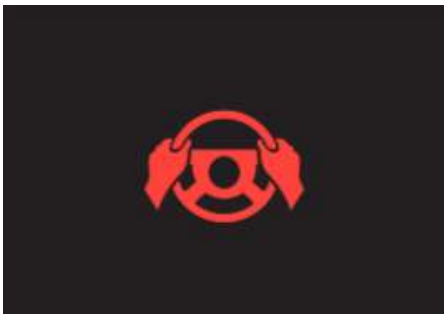
The customer complains that fault messages relating to the driver assist systems appear together with the take over steering prompt **only** shortly after starting the vehicle.

**Figure 1.** Take over steering warning light.

- Proactive occupant protection: currently unavailable
- Driver assist systems currently restricted
- Emergency Assist: fault. You can continue driving (in combination with the red take over steering prompt (see image 1)).

**If the red warning lamp for the take over steering prompt (Figure 1) is not active, this TSB does NOT apply.**
