| Model(s) | Year(s) | VIN Range | Vehicle Specific Equipment |
|---|---|---|---|
| A5, S5 (FU), Q5, Q5 Sportback, SQ5, SQ5 Sportback (FU), A6 Sportback e-tron, S6 Sportback e-tron, Q6 e-tron, Q6 Sportback e-tron, SQ6 e-tron, and SQ6 Sportback e-tron | 2025 | All | Not applicable |

This TSB replaces PSS 2079757, *90 PSS PPE/PPC: warning messages about assist systems – U171200*

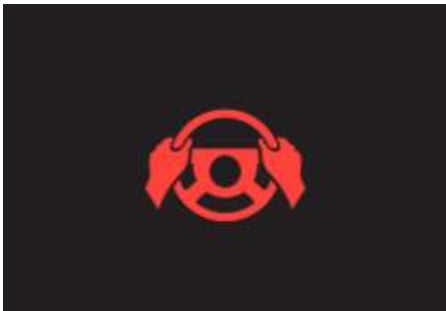
The customer complains that fault messages relating to the driver assist systems appear together with the take over steering prompt **only** shortly after starting the vehicle.

**Figure 1.** Take over steering warning light.

- Emergency Assist: fault. You can continue driving (in combination with the red take over steering prompt (see Figure 1)).

**If the red warning lamp for the take over steering prompt is not active, this TSB does NOT apply.**

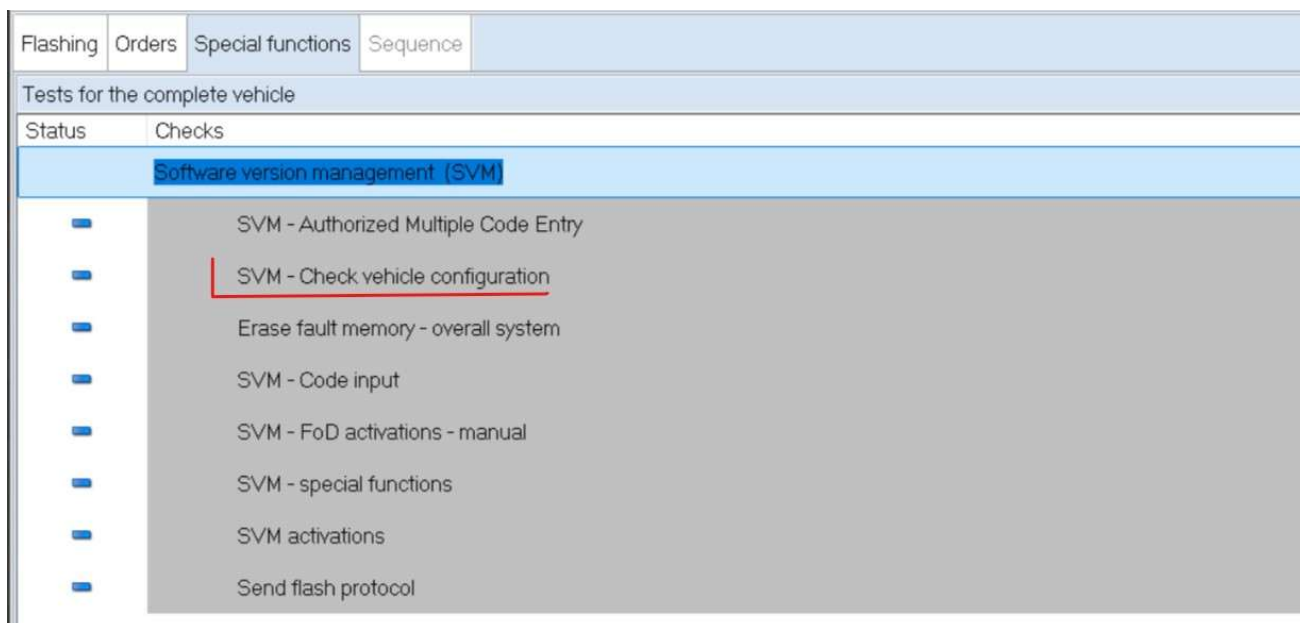
**Figure 2: ODIS SVM Test Plan**

1. Run the test program **"SVM – Check vehicle configuration"** in ODIS (Figure 2). This step is required to use the SVM-code in step 2.
2. Select the "Flash" function, select "SVM code input" and enter the code **EGDHCP5DA0019**.
3. Flashing will be performed. Due to a system restriction, the procedure will end with the error 8113. Ignore this error. If a different error code appears, proceed as specified in the error message.
4. Run the **"SVM – Check vehicle configuration"** test program in ODIS again.
5. Perform a sleep cycle, end the diagnostic session, and send the diagnostic log online.
