# HYUNDAI

## Technical Service Bulletin

| GROUP<br><b>CAMPAIGN</b> | NUMBER<br><b>26-01-021H</b> |

**SUBJECT:** ECM SOFTWARE UPDATE – DTC P050500, P050600  
(LIMITED COVERAGE CAMPAIGN LA16)

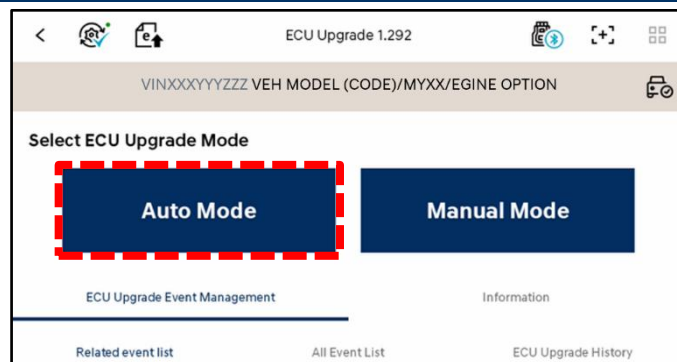
1. Perform the ECU update in **Auto Mode**.

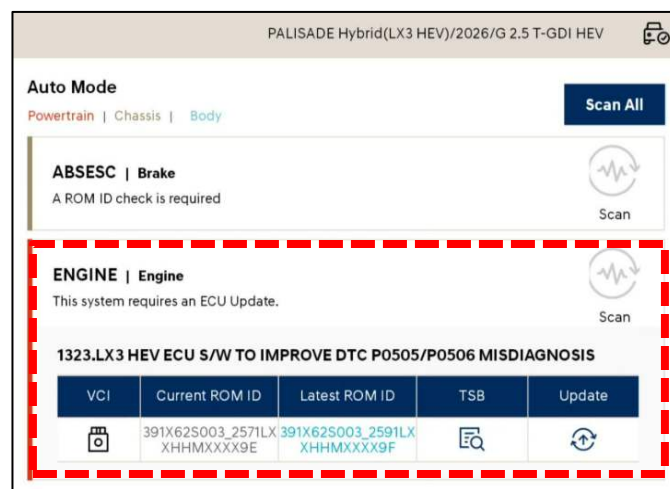
2. Verify the ROM ID by selecting the **ENGINE** system to scan the vehicle's current ROM ID.

Check the current ROM ID version and compare it to the ROM ID Information table before attempting to perform the software update.

If the update fails, remove the power connector from the in-cabin fuse box for at least **5 seconds**. Alternatively, disconnect the negative (–) **12V** battery terminal and wait at least **5 seconds**. Reassemble and retry the update.

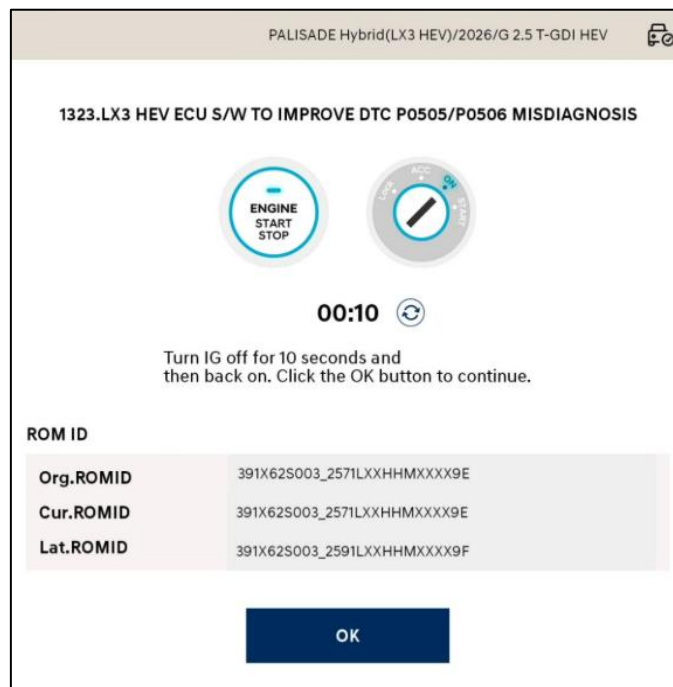
3. After the ECU update process shows 100% complete, follow the prompts on the screen to cycle the ignition **OFF** for at least **10 seconds** to reset the control unit (certain models may take up to **30 seconds**).

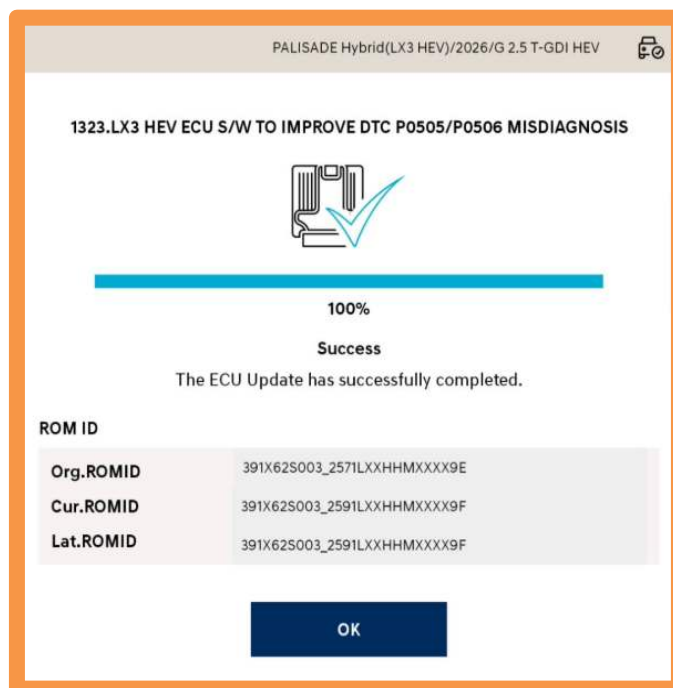
Using the tablet or GDS screen capture function, take a screenshot of the ECU Update "Success" result screen.

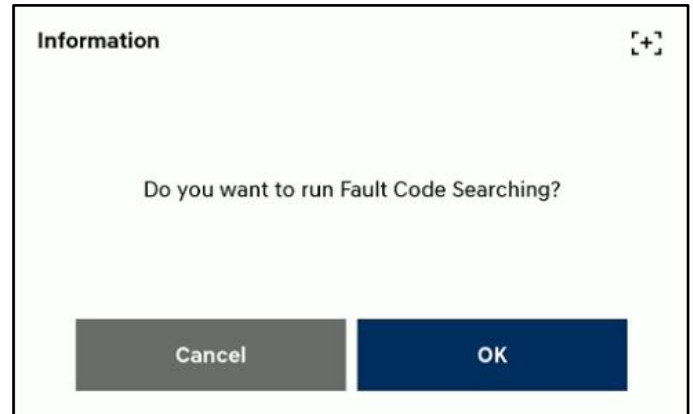
5. Perform an **All Systems Fault Code** search and erase DTC history that had incidentally occurred from the ECU update.
