**HYUNDAI**  
**Technical Service Bulletin**

| GROUP<br><b>CAMPAIGN</b> | NUMBER<br><b>26-01-026H</b> |
| DATE<br><b>FEBRUARY 2026</b> | MODEL(S)<br><b>PALISADE (LX3)<br/>PALISADE HYBRID<br/>(LX3 HEV)</b> |

**SUBJECT:** ACTIVE AIR FLAP WIRING ASSEMBLY INSPECTION & REPLACEMENT (LIMITED COVERAGE CAMPAIGN LA13)

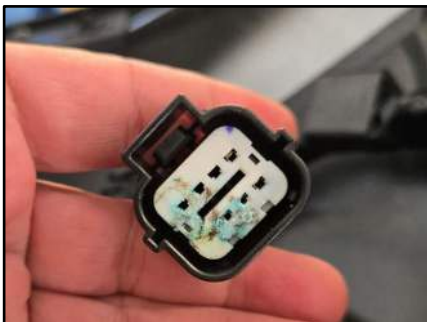
AAF Front Bumper Wiring Connector

**Description:** Certain Palisade (LX3) and Palisade Hybrid (LX3 HEV) vehicles may exhibit a “Check Active Air Flap System” warning message, check engine light on, and/or “Low Engine Oil” warning message, due to improper operation of the Active Air Flap (AAF) system. DTCs include, but are not limited to: P05AE00, P05B100, P05B200 P05B400, P05FE00, P15A200, P15A500, P2C7400, U028500, U028B00, and/or U100800. This condition may be caused by water ingress and corrosion at the wiring connections for the lower AAF actuators and/or sensors. This bulletin contains instructions to inspect the front bumper wiring connectors, AAF actuators, and sensors for water ingress and corrosion, and to replace them if necessary.

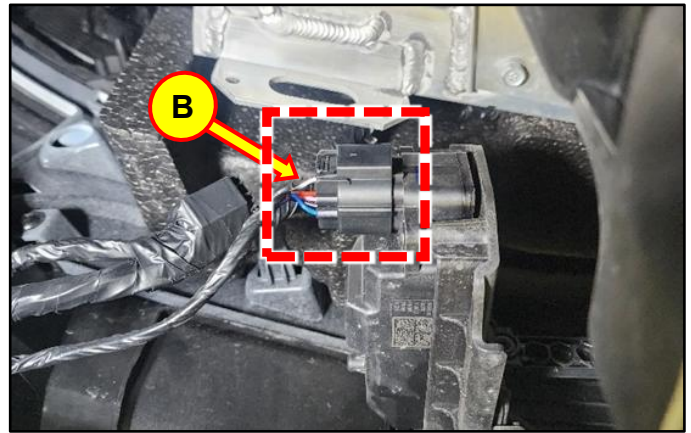
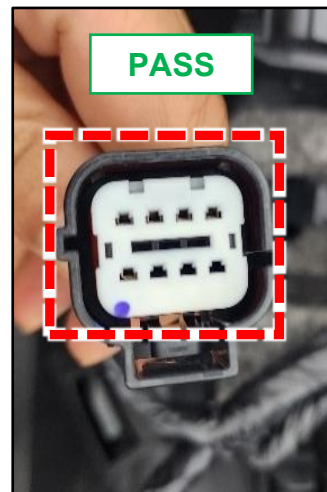
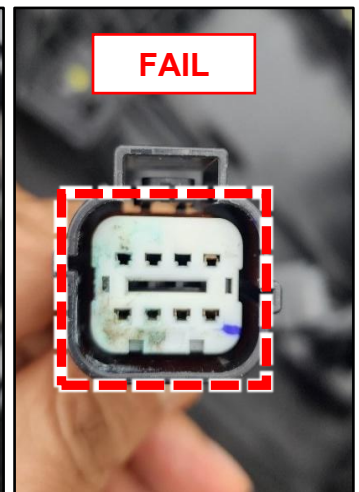
Visually inspect both the LH and RH front bumper wiring connectors for water ingress or corrosion.

At right are examples of good (**PASS**) and damaged (**FAIL**) wiring connectors.

- **PASS**: If damage is **NOT** found on either LH or RH connectors:
  - Proceed to **step 4**.
- **FAIL**: If damage is found,
  - On **ONE** side **ONLY**: Proceed to **step 4**.
  - On **BOTH** sides: Proceed to the **Front Bumper Removal** procedure.

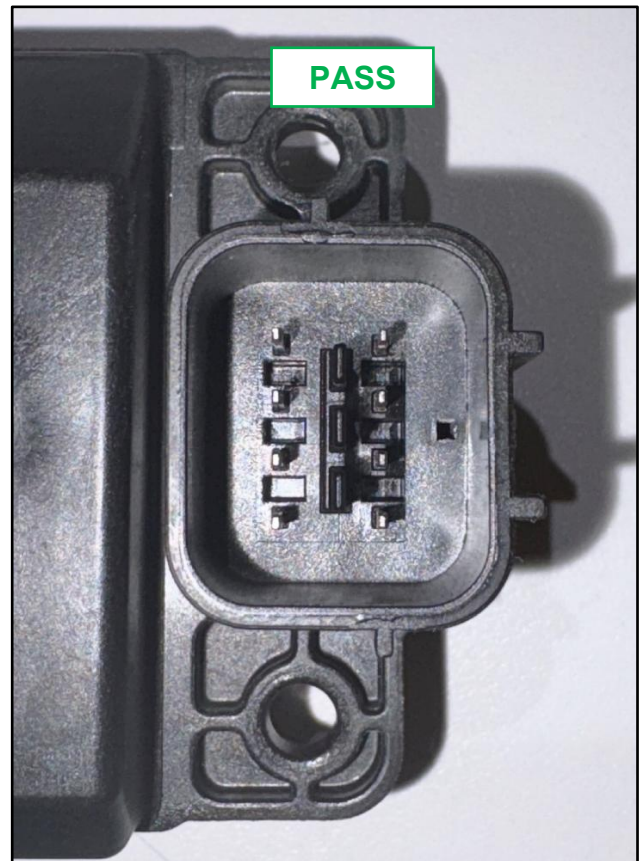
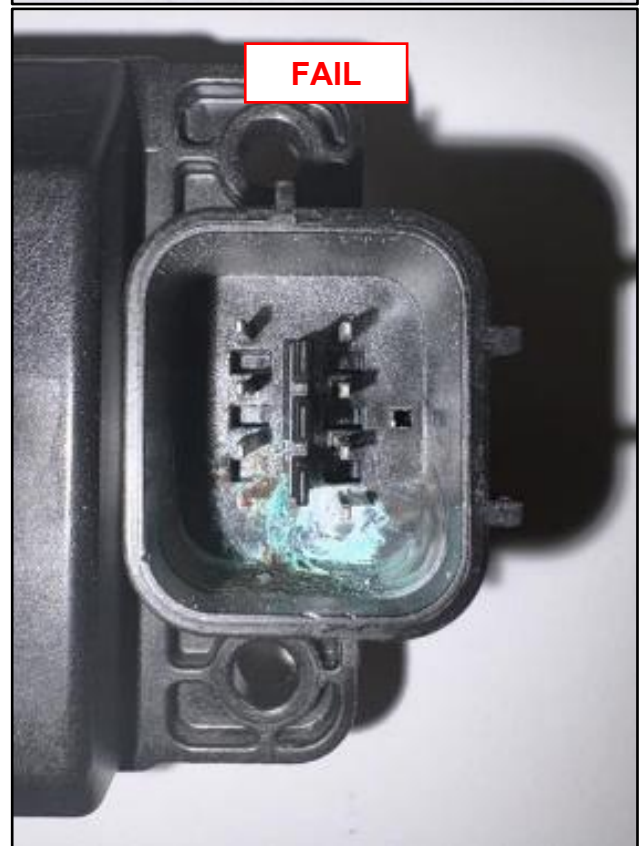
4. On the side(s) that received a **PASS** in **step 3**, use a small mirror and flashlight to inspect the AAF actuator pins for water ingress or corrosion to ensure no damage is missed.

At right are examples of good (**PASS**) and damaged (**FAIL**) actuator pins.

- **PASS:** If damage is **NOT** found in **BOTH** inspections (**steps 3 and 4**), proceed to **step 5**.
- **FAIL:** If damage is found in either inspection (**step 3 or 4**), proceed to the **Front Bumper Removal** procedure.

If **ANY** corrosion or water ingress evidence is found, even if it is minor, the inspection is still a **FAIL**.

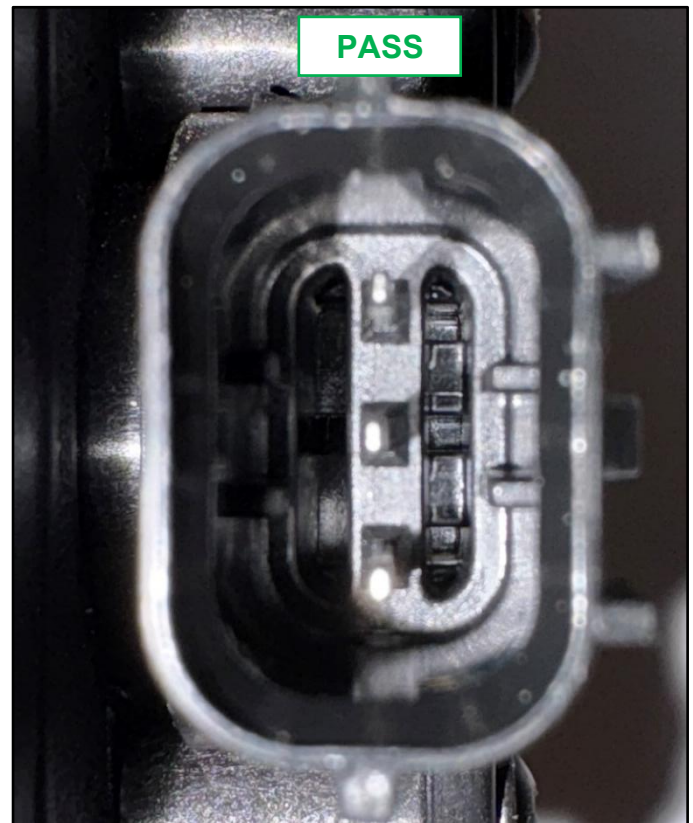
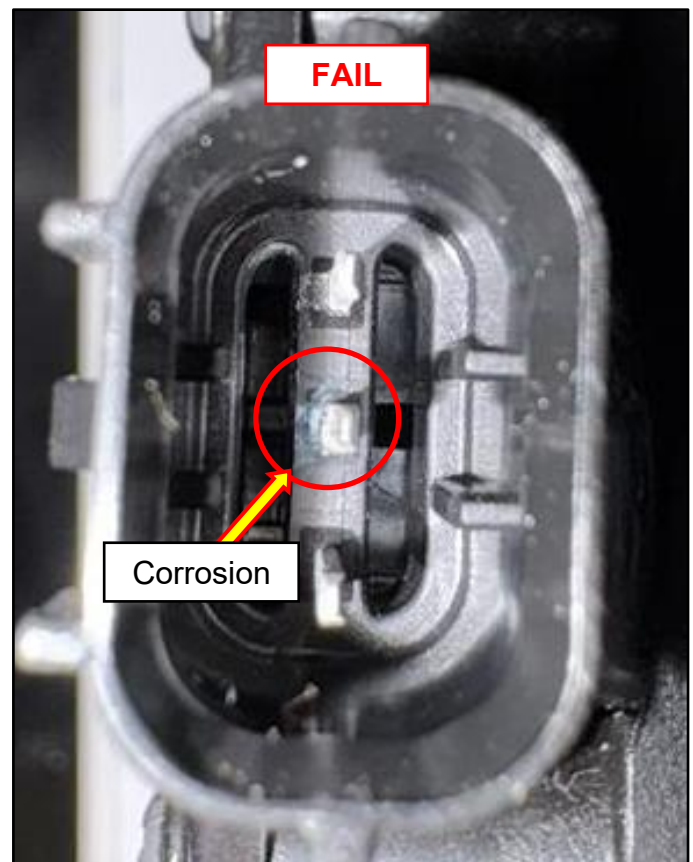
2. Visually check LH/RH sensor connections for water/corrosion ingress.

If the RH side **PASSED** the **Front Bumper Wiring & AAF Actuator Pin Inspection** procedure, but RH **sensor** is found to have corrosion/water ingress, then proceed to replace **BOTH** LH and RH parts as stated in **step 3** of the **Replacement of Front Bumper Harness, AAF Actuator(s), and AAF Sensor(s)** procedure.

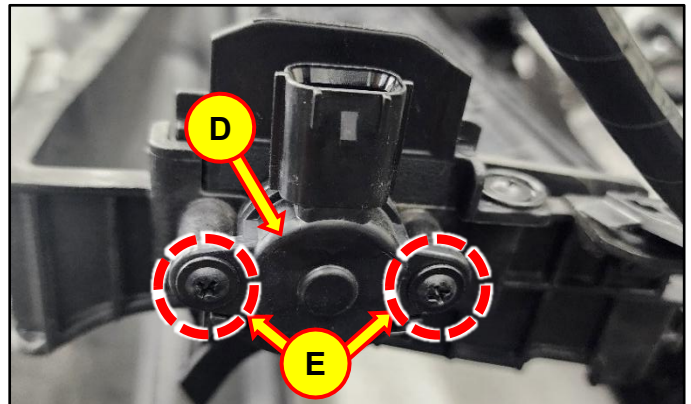
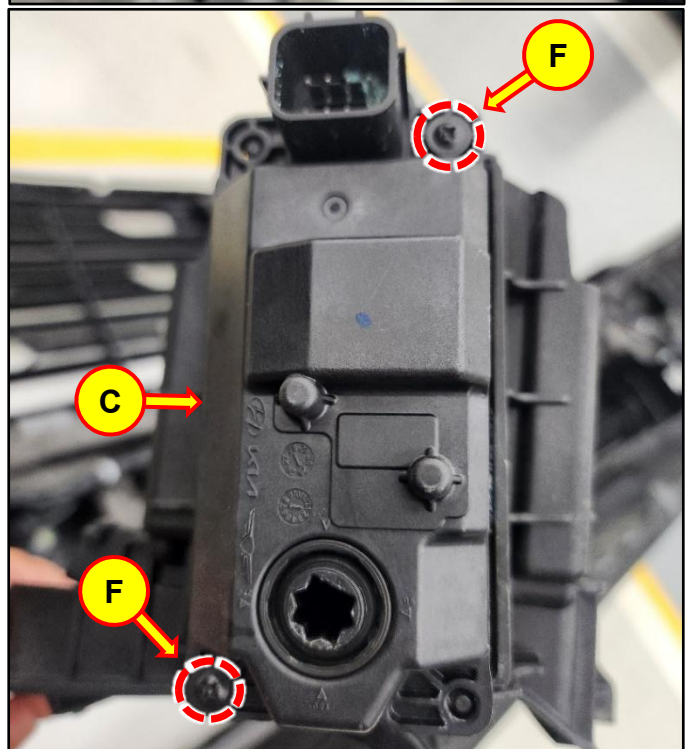
3. If **ONLY** the LH side is affected by water ingress/corrosion, then **ONLY** remove the LH side AAF actuator (C) and sensor (D) by removing the mounting screws (E and F).

If the RH side is affected by water ingress/corrosion, then remove **BOTH** LH and RH side AAF actuators (C) and sensors (D) by removing the mounting screws (E and F).
