# Service Alert

CHECK ENGINE LIGHT ON WITH DTC P061B, LIGHT INCREASE  
IN ENGINE RPMS DURING ACCELERATION, TRANSMISSION  
WON'T SHIFT PAST 4TH GEAR, VARIOUS U CODES SET

Service Alert No.: SA-011/26

2018-2025 CX-5

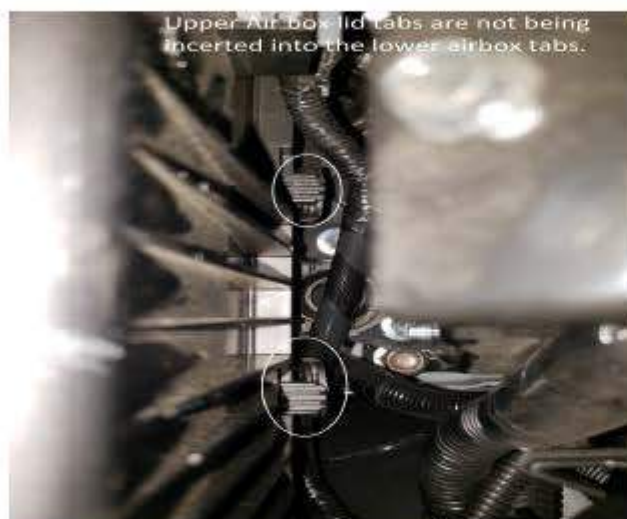
Upper air box tabs are not inserted into the lower air box tabs. Turbulent air is entering the air box, affecting the MAF.

1. Open the hood.
2. Grasp the air cleaner assembly by hand and gently pull it toward the front of the vehicle.
  - If the air cleaner assembly moves, inspect the three (3) tabs at the lower rear area of the air cleaner assembly. Ensure that all three (3) tabs are properly attached to the lower air cleaner assembly.
  - If the air cleaner assembly is properly attached, inspect that the air filter is properly sealing the upper and lower air filter box and not letting turbulent air to leak past the mating surfaces. If OK, perform a normal diagnosis according to the instructions on MGSS online.

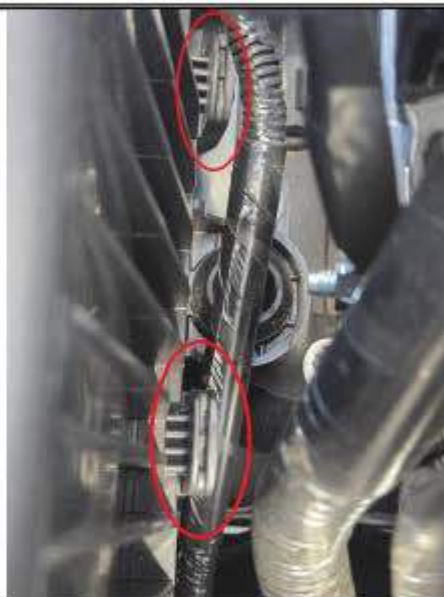
Properly inserted upper and lower tabs. The air box is sealed from the turbulent underhood air.
