# Technical Service Bulletin

| <b>Topic</b> | Keyless door entry does not work - Front Outside Door Handle(s) - Touch Sensor DTC B147613 and/or B147713 are present |
| <b>Transaction No.</b> | 2062257/7 |

# Continental GT/GTC and Flying Spur Series

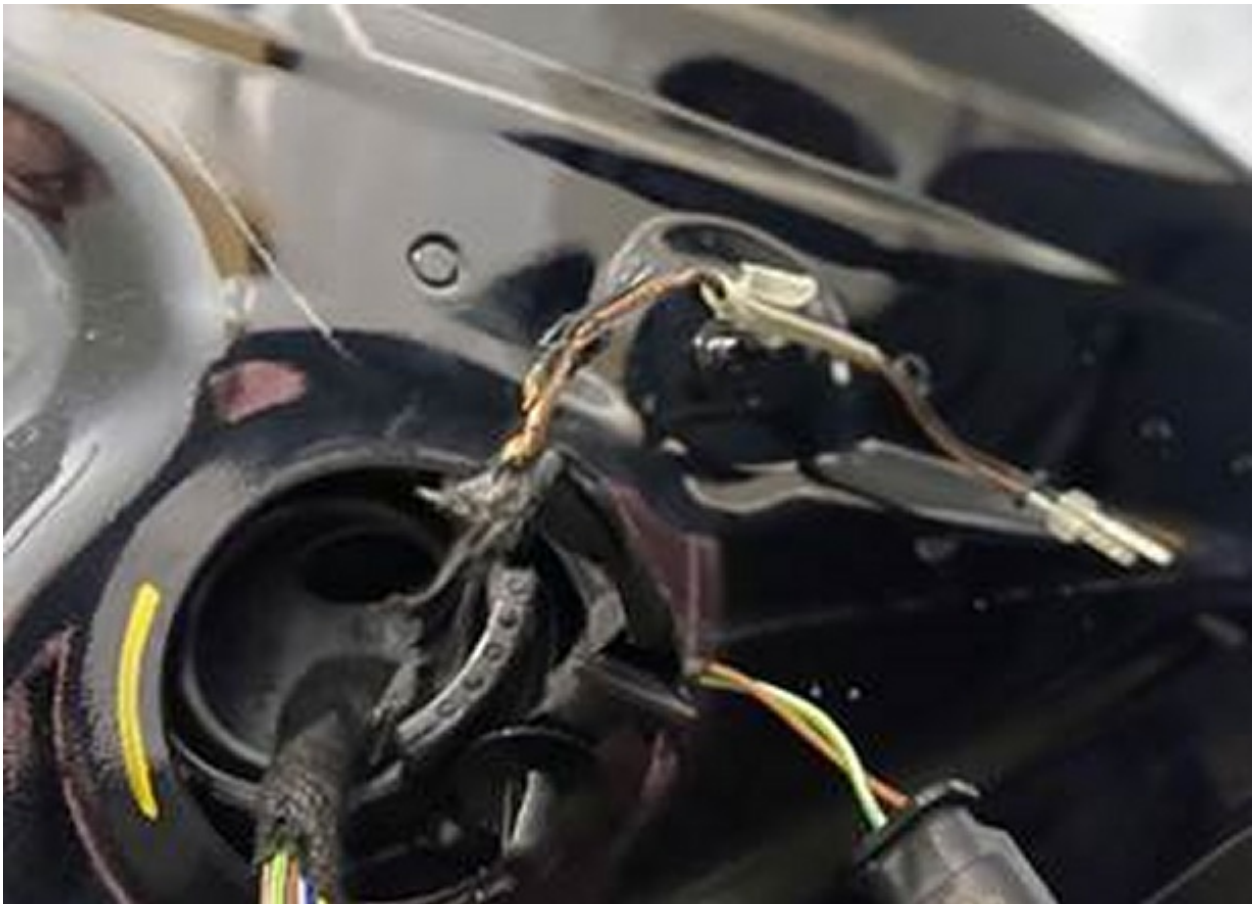
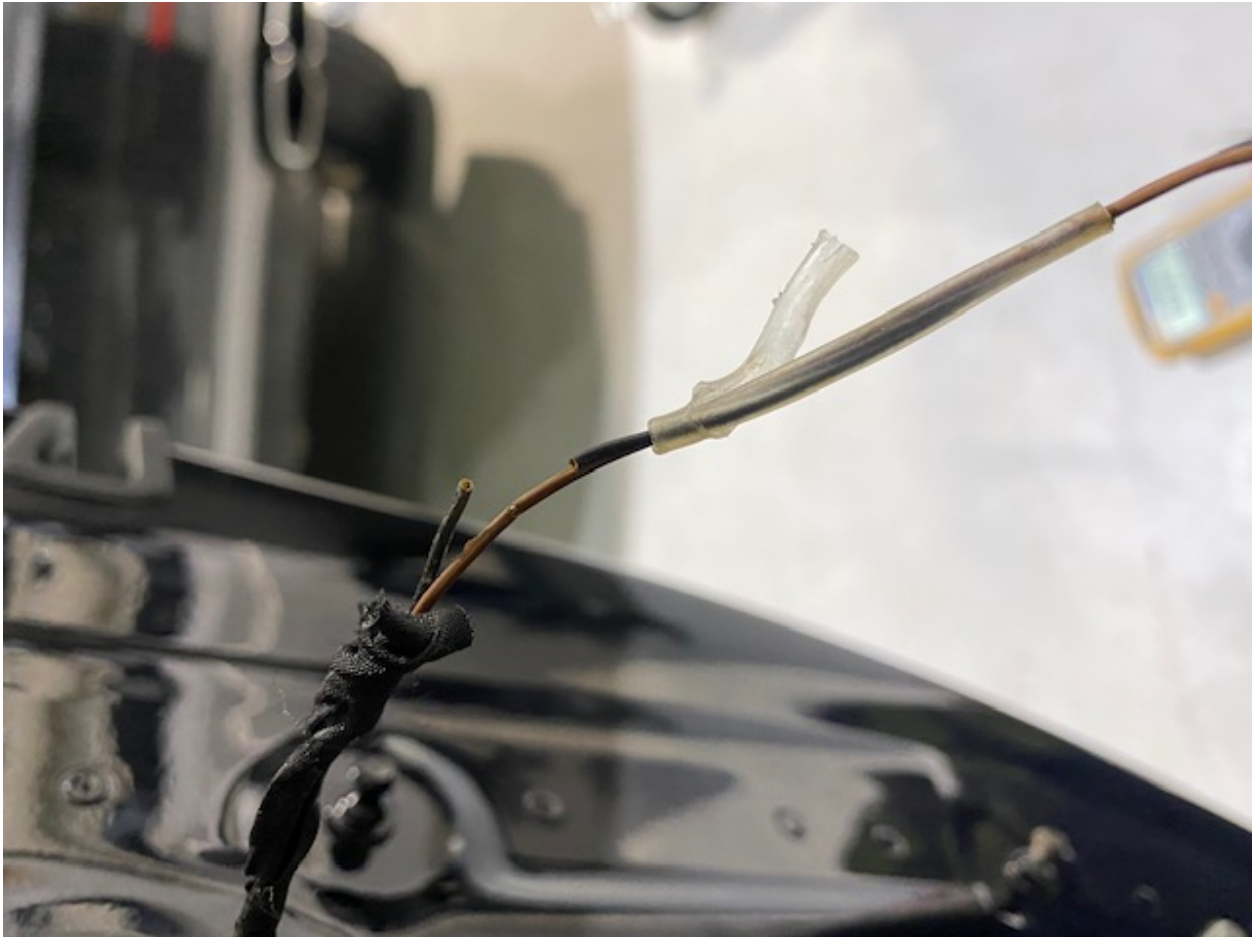
- Referring to Figures 1 and 2 - Perform a check of the wiring that is routed through the exterior door handle (from the convenience control module), including the wiring inside the clear heat shrink and/or insulation tape
- In the event that any wires show damage or signs of chaffing/breaks continue with the suggested repair as detailed in Step 3

3) Repair the broken or damaged wires as per Rep.Gr 97

TIP: Where possible, extend the length of the wires by 10mm

- Ensure the wiring does not clash with and components in particular the window mechanism
