## STAR ONLINE PUBLICATION

**Case Number: S268A000008**

**Models:** 2022-2026 Ram 2500 Pickup (DJ)  
2022-2026 Ram 3500 Pickup (D2)  
2022-2026 Ram 3500 Cab Chassis (DD)  
2022-2026 Ram 4500/5500 Cab Chassis (DP)  
2022-2026 Ram 1500 (DT)  
2024-2026 Jeep Wrangler (JL)  
2024-2026 Jeep Gladiator (JT)  
2021-2026 Chrysler Pacifica/Voyager (RU)  
2021-2026 Dodge Durango (WD)

**Symptom/Vehicle Issue:** Uconnect Box Requires Service, Please Visit an Authorized Dealer Message on Display Message With DTCs B1498-13, B1498-19 or B1570-93

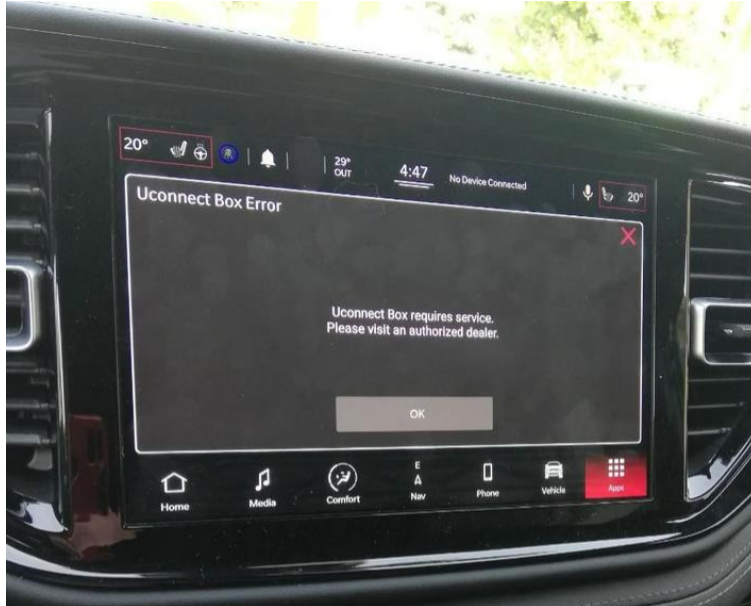
Fig 1

The current service procedure may misguide technicians by instructing them to replace the media hub. These DTCs are unrelated to the media hub and indicate a communication fault between the Radio and the Telematics Box Module (TBM). Engineering is working on updating diagnostics.

Technicians may see DTCs B1498-13 USB Hub-Circuit Open, B1498-19 USB Hub Overcurrent or B1570-93 USB Communication No Operation. Do not replace Media Hub, check the USB wiring between TBM and Radio for a possible open or short. The wiring harness is a Y from radio to both TBM and Media Hub.

1. Verify DTCs
  - Confirm B1498-13, and/or B1498-19 and/or B1570-93 are present.
  - Clear codes and retest after ignition cycle.
2. Check for related DTCs
  - Scan for additional communication or network codes that may indicate broader harness or module issues.

- 3 Inspect circuit integrity between Radio and TBM
  - Check harness connections at both ends (radio and TBM), check wiring harness for damage or pinched areas.
  - Inspect connector terminals for bent pins, corrosion, or loose fit.
  - Perform continuity and voltage checks on the communication lines.
- 4 Module Reset
  - Power cycle the vehicle to reset both the Radio and TBM modules.
  - After the reset, verify whether the DTCs return.
