| <b>HYUNDAI</b><br><b>Technical Service Bulletin</b> | GROUP<br><b>ADAS</b> | NUMBER<br><b>26-AD-001H</b> |
| | DATE<br><b>FEBRUARY 2026</b> | MODEL(S)<br><b>SEE BELOW</b> |
| <b>SUBJECT:</b> FRONT VIEW CAMERA WARNING AND CALIBRATION<br>(DTC C272246) | | |

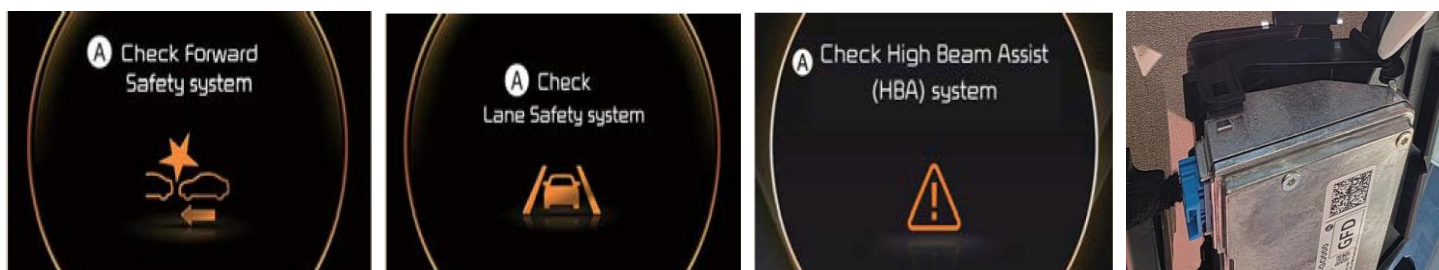
#### C272246 – System Out of Calibration

Possible Warning lights due to the front camera exceeding its calibration tolerance:

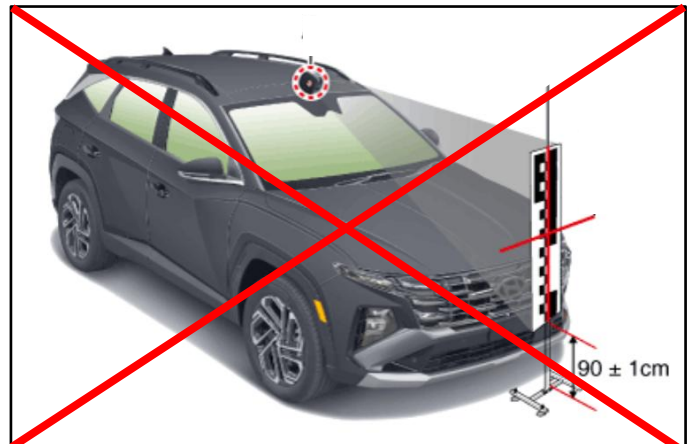
If **DTC 2721** is triggered, turn the ignition **OFF/ON** and then perform the driving calibration with the usage of the GDS.

Select "**FR/CMR – Front View Camera**", "**Front Camera Driving Calibration (SPC)**", and follow the instructions in the GDS to perform the driving calibration.

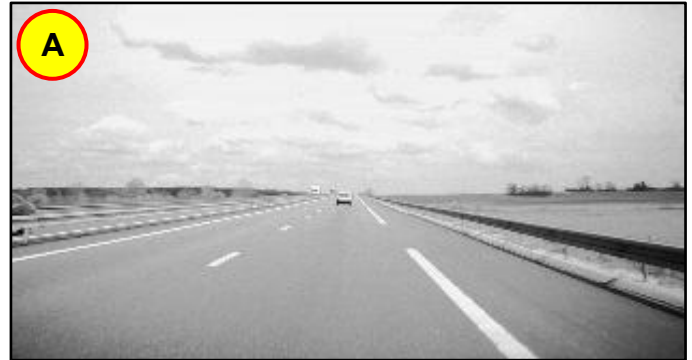
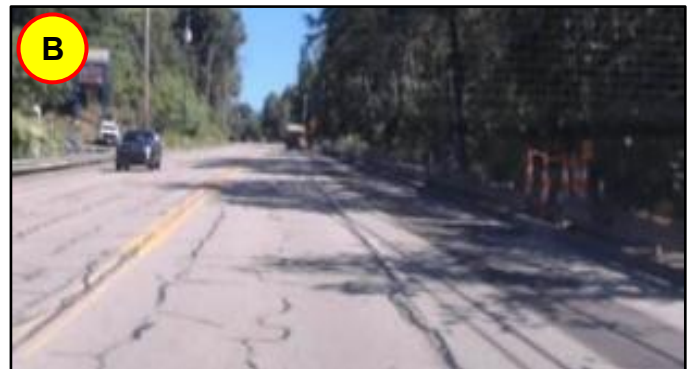
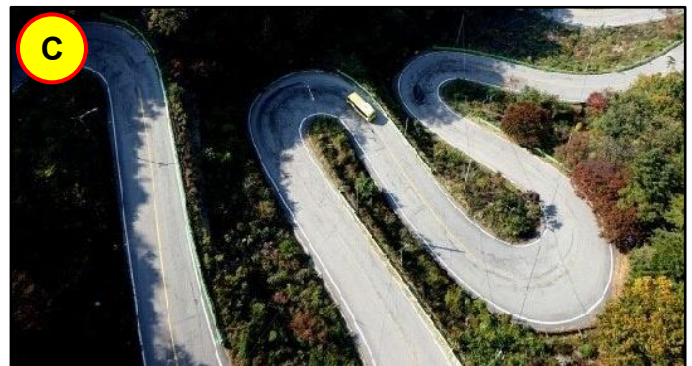
Calibration may fail when conducted on a road with too much surface damage (B) or too many curves (C).

If attempt to perform front camera calibration while **DTC C2722** is **ACTIVE**, it will cause **DTC C272146** (System Calibration Required).

If **DTC C272146** occurs, turn the ignition **OFF/ON**, then perform driving calibration with GDS.
