# Service Bulletin

Bulletin No.: PIT6494  
Date: March, 2026

**Subject:** Malfunction Indicator Lamp (MIL) DTC P3075- Radiator Inlet Hose Coolant Leak

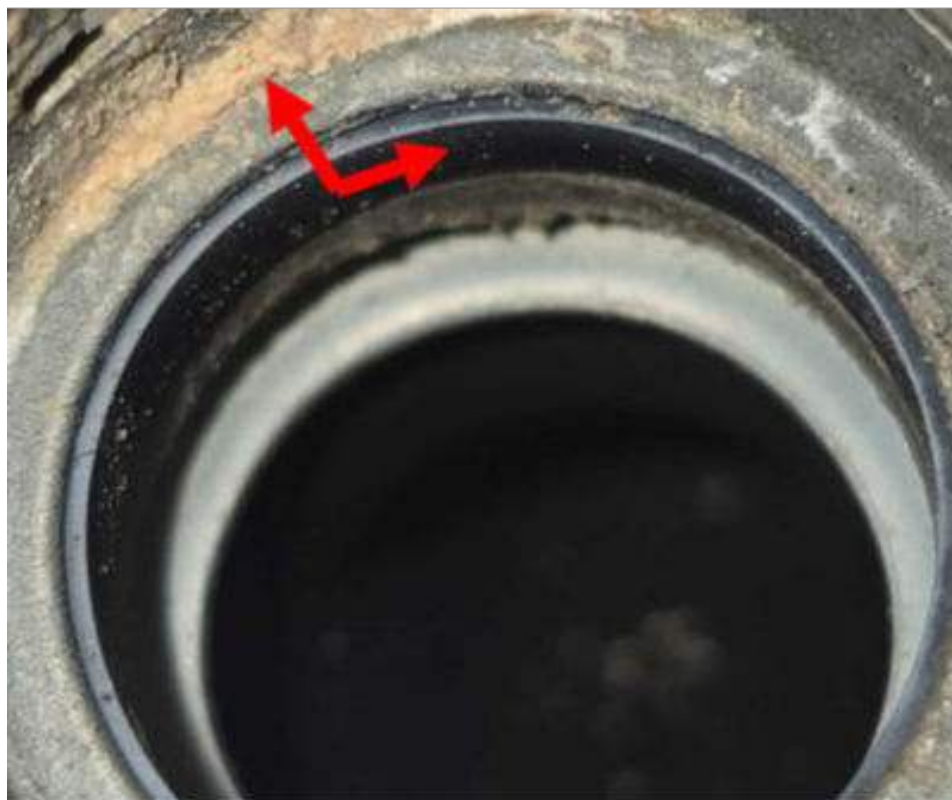
7097960

| Cause | <p>The condition may be caused by coolant leakage at the upper radiator hose quickconnect fitting due to a degraded inlethose seal.</p> <p>This leakage originates from the radiator inlet hose seal itself and is not the result of a radiator failure. Seal wear may present with varying levels of residue or buildup depending on vehicle usage and operating environment.</p> <p>Visual inspection of a failed lip seal—typically showing material flattening and residue accumulation around the connection—indicates seal degradation rather than a radiator defect. See Graphic.</p> |

1) Drain the cooling system. Refer to Cooling System Draining and Filling in SI.

2) Remove the Radiator Inlet Hose from the vehicle. Refer to Radiator Inlet Hose Replacement. Recommend using a lint-free (clean) cloth to wipe the radiator spigot prior to reassembling the hose to remove any residual contaminate that may be present from the coolant hose. The surface should be smooth and free of contaminate prior to installation of the new hose to prevent leakage.
