## Technical Service Bulletin

26-EM-008G

GV70 (JK1A)

CLOGGED DUAL PURGE EJECTOR ASSEMBLY & INTERCOOLER  
OUTLET DEBRIS – DTC P04F000

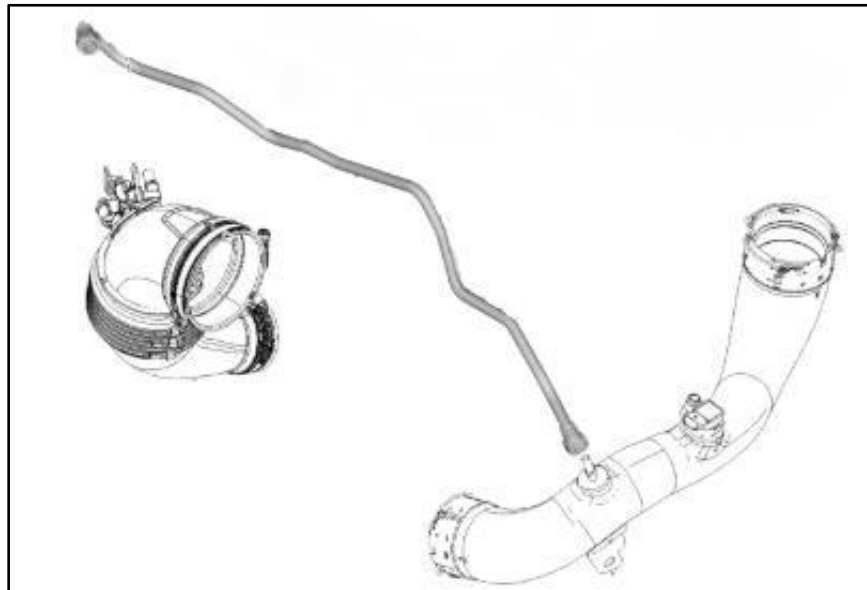
**Description:** Some GV70 (JK1A) vehicles equipped with 2.5T engines may display a check engine light with DTC P04F000 (EVAP System High Load Purge Line 'A' Performance) due to debris inside the dual purge ejector assembly and/or intercooler outlet hose. This bulletin provides instructions to perform a DTC check, and if necessary, replace the dual purge ejector assembly and intercooler outlet hose.
