| REFERENCE: | TSB: 08-089-26<br>GROUP: 08 - Electrical | Date: | March 7, 2026 | REVISION: | 08-071-25 REV. D |
| VEHICLES AFFECTED: | 2024 (LB) Dodge Charger<br>This bulletin applies to vehicles equipped with 400V G2500 FR/RR Elec Drive Motors (Sales Code ELD). | | | MARKET APPLICABILITY:<br><div><input checked="" type="checkbox"/> NA<input type="checkbox"/> MEA<br/><input type="checkbox"/> SA<input type="checkbox"/> IAP<br/><input type="checkbox"/> EE<input type="checkbox"/> CH</div><br><b>NOTE:</b> This bulletin applies to the North America markets. | |

| <b>CAUSE:</b> | <b>BPCM software update</b> |

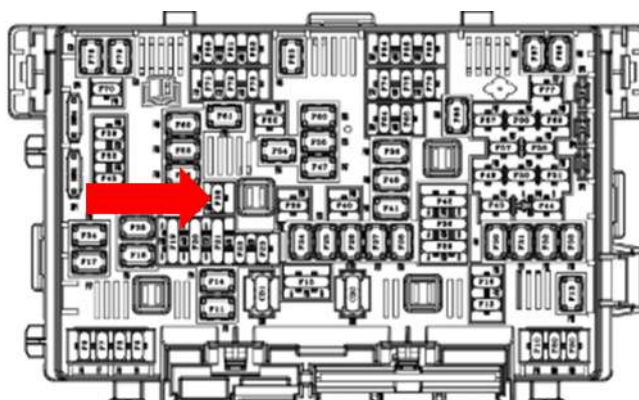
**Fig. 3**  
#38 AGSM Fuse Location

**Failure to remove the #38 AGSM fuse will result in damage to the shifter.**

6. Remove the PDC cover, locate and remove the #38 AGSM fuse [Fig. 3](#).
