| REFERENCE: | TSB: 08-090-26<br>GROUP: 08 - Electrical | Date: | March 7, 2026 | REVISION: | 08-022-25 REV. D |
| VEHICLES AFFECTED: | 2024 (LB) Dodge Charger<br>This bulletin applies to vehicles equipped with 400V G2500 FR/RR Elec Drive Motors (Sales Code ELD). | | | MARKET APPLICABILITY:<br><div><input checked="" type="checkbox"/> NA<input type="checkbox"/> MEA<br/><input type="checkbox"/> SA<input type="checkbox"/> IAP<br/><input type="checkbox"/> EE<input type="checkbox"/> CH</div><br><b>NOTE:</b> This bulletin applies to North America markets. | |

| <b>CAUSE:</b> | <b>BPCM software update</b> |

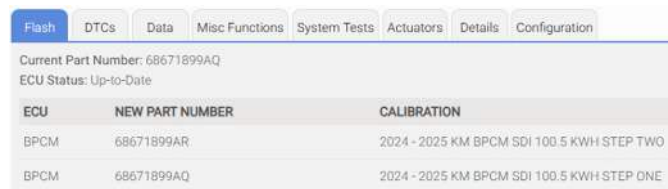
**Fig. 4**

**\*\*Two Step Software Level AQ And AR Screen\*\***

If the BPCM is already at the **\*\*AQ\*\*** level, the module must be reprogrammed to the **\*\*AR\*\*** level. Do not over flash at the **\*\*AQ\*\*** level to get to the **\*\*AR\*\*** level.

7. Inspect the software level on the BPCM by going into the "Flash" tab and compare to what software is available [Fig. 4](#).

8. Is the BPCM software at the **\*\*AQ\*\*** level?
  - YES >>> Proceed to [Step 10](#).
  - NO >>> Proceed to [Step 9](#).
9. Reprogram the BPCM to the **\*\*AQ\*\*** level. **Then proceed to Step 10.**

10. Reprogram the BPCM to the **\*\*AR\*\*** level.
11. Reprogram the BPCM to the latest available software.
12. Clear DTCs.
13. Are any of the following DTCs now active or pending in the BPCM?
