## Technical Service Bulletin (TSB)

### Flash: Motor Control Processor B (MCP B) Updates 11B3

| REFERENCE: | TSB: 08-092-26<br>GROUP: 08 - Electrical | Date: | March 7, 2026 | REVISION: | 08-021-25 REV. D |
| VEHICLES AFFECTED: | 2024 (LB) Dodge Charger<br>This bulletin applies to vehicles equipped with 400V G2500 FR/RR Elec Drive Motors (Sales Code ELD). | | | MARKET APPLICABILITY:<br><div><input checked="" type="checkbox"/> NA<input type="checkbox"/> MEA<br/><input type="checkbox"/> SA<input type="checkbox"/> IAP<br/><input type="checkbox"/> EE<input type="checkbox"/> CH</div><br>NOTE: This bulletin applies to North America markets. | |

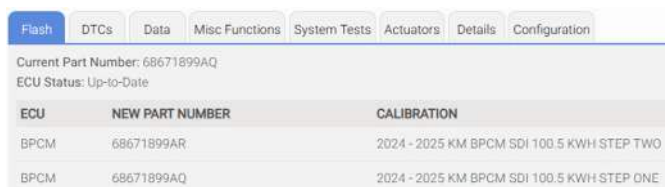
**Fig. 4**

**\*\*Two Step Software Level AQ And AR Screen\*\***

If the BPCM is already at the **\*\*AQ\*\*** level, the module must be reprogrammed to the **\*\*AR\*\*** level. Do not over flash at the **\*\*AQ\*\*** level to get to the **\*\*AR\*\*** level.

7. Inspect the software level on the BPCM by going into the "Flash" tab and compare to what software is available [Fig. 4](#).
