## Technical Service Bulletin (TSB)

### Flash: Motor Control Processor A (MCP A) Updates 6B3

| REFERENCE: | TSB: 08-097-26<br>GROUP: 08 - Electrical | Date: | March 7, 2026 | REVISION: | 08-027-25 REV. D |
| VEHICLES AFFECTED: | 2025 (LB) Dodge Charger<br>This bulletin applies to vehicles equipped with 400V G2500 FR/RR Elec Drive Motors (Sales Code ELD). | | | MARKET APPLICABILITY:<br><div><input checked="" type="checkbox"/> NA<input type="checkbox"/> MEA<br/><input type="checkbox"/> SA<input type="checkbox"/> IAP<br/><input type="checkbox"/> EE<input type="checkbox"/> CH</div><br>NOTE: This bulletin applies to North America markets. | |

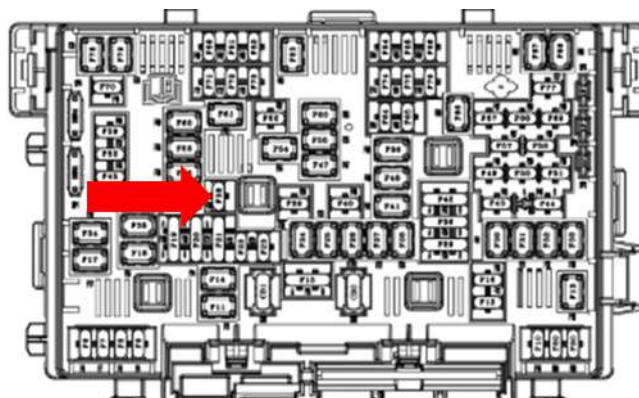
**Fig. 3**  
#38 AGSM Fuse Location

**Failure to remove the #38 AGSM fuse will result in damage to the shifter.**

6. Remove the PDC cover, locate and remove the #38 AGSM fuse [Fig. 3](#).

35. Install the #38 AGSM fuse [Fig. 3](#) and the PDC cover [Fig. 2](#).
36. Position the rear carpet in place.
37. Connect the cooling fan wire harness connector [Fig. 1](#).
38. Install the front storage bin. Refer to the detailed service procedures available in DealerCONNECT/ServiceLibrary under: Service Info> 23 - Body / Exterior / Bin, Storage / Installation.
39. Clear any DTCs that may have been set in any modules due to reprogramming. The wiTECH application will automatically present all DTCs after the flash and allow them to be cleared.

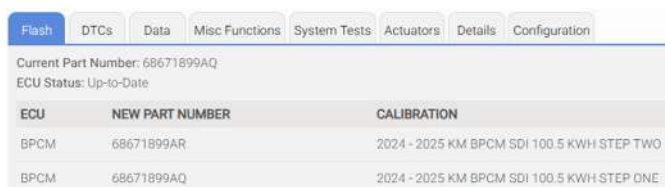
**Fig. 4**

Two Step Software Level \*\*AQ And AR\*\* Screen

If the BPCM is already at the **\*\*AQ\*\*** level, the module must be reprogrammed to the **\*\*AR\*\*** level. Do not over flash at the **\*\*AQ\*\*** level to get to the **\*\*AR\*\*** level.

7. Inspect the software level on the BPCM by going into the "Flash" tab and compare to what software is available [Fig. 4](#).

8. Is the BPCM software at the **\*\*AQ\*\*** level?
  - YES >>> Proceed to [Step 10](#).
  - NO >>> Proceed to [Step 9](#).
9. Reprogram the BPCM to the **\*\*AQ\*\*** level. Then proceed to [Step 10](#).

10. Reprogram the BPCM to the **\*\*AR\*\*** level.
11. Reprogram the BPCM to the latest available software.
12. Clear DTCs.
13. Are any of the following DTCs now active or pending in the BPCM?
