**Technical Service Bulletin (TSB)**  
**RSU With Additional Sleep Cycles for HV Battery Integrity Check**  
**- Flash: Electronic Vehicle Control Unit (EVCU) Updates 11B3**

| REFERENCE: | TSB: 08-099-26<br>GROUP: 08 - Electrical | Date: | March 7, 2026 | REVISION: | 08-075-25 REV. C |
| VEHICLES AFFECTED: | 2024 (LB) Dodge Charger<br>This bulletin applies to vehicles equipped with 400V G2500 FR/RR Elec Drive Motors (Sales Code ELD). | | | MARKET APPLICABILITY:<br><div><input checked="" type="checkbox"/> NA<input type="checkbox"/> MEA<br/><input type="checkbox"/> SA<input type="checkbox"/> IAP<br/><input type="checkbox"/> EE<input type="checkbox"/> CH</div><br>NOTE: This bulletin applies to the North America markets. | |

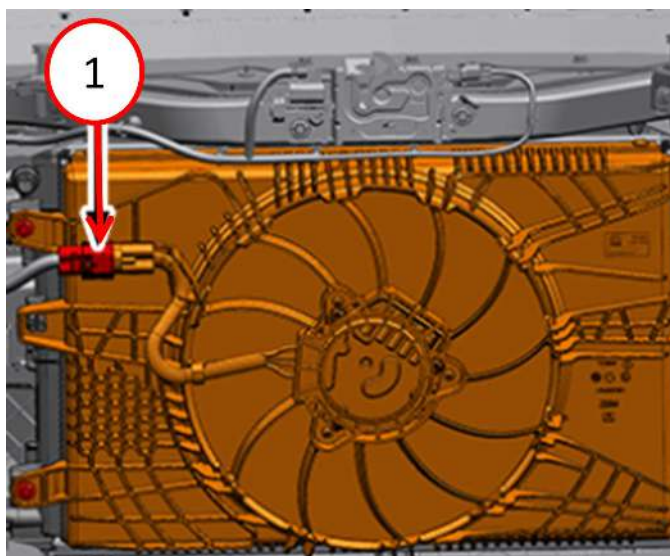
**Fig. 1**  
Cooling Fan Assembly

**NOTE: The cooling fan must be disconnected to prevent it from powering on, which may interrupt/ abort the flash process.**

1 - Wire Harness To Disconnect/Connect

4. Disconnect the cooling fan wire harness connector [Fig. 1](#).

37. Connect the cooling fan wire harness connector [Fig. 1](#).

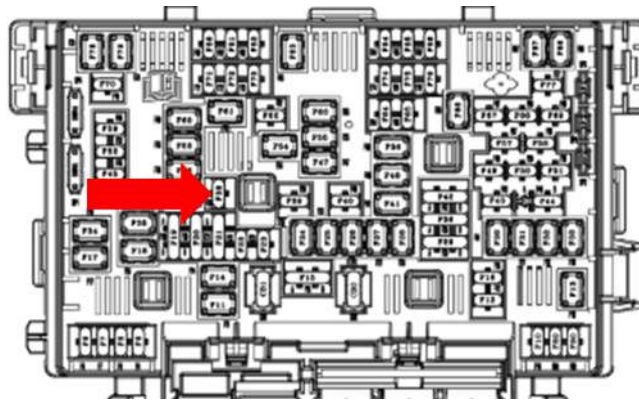
**Fig. 3**  
#38 AGSM Fuse Location

**Failure to remove the #38 AGSM fuse will result in damage to the shifter.**

6. Remove the PDC cover, locate and remove the #38 AGSM fuse [Fig. 3](#).

35. Install the #38 AGSM fuse [Fig. 3](#) and the PDC cover [Fig. 2](#).
