## STAR ONLINE PUBLICATION

**Case Number:** S2608000006 Rev. A

**Models Affected:** 2026 Jeep Cherokee (KM)

**Symptom/Vehicle Issue:** Limp Home Mode, Red Wrench Lamp Illuminated. DTCs P0C01-00 - Drive Motor A Current High And/Or P0C04-00 - Drive Motor B Current High

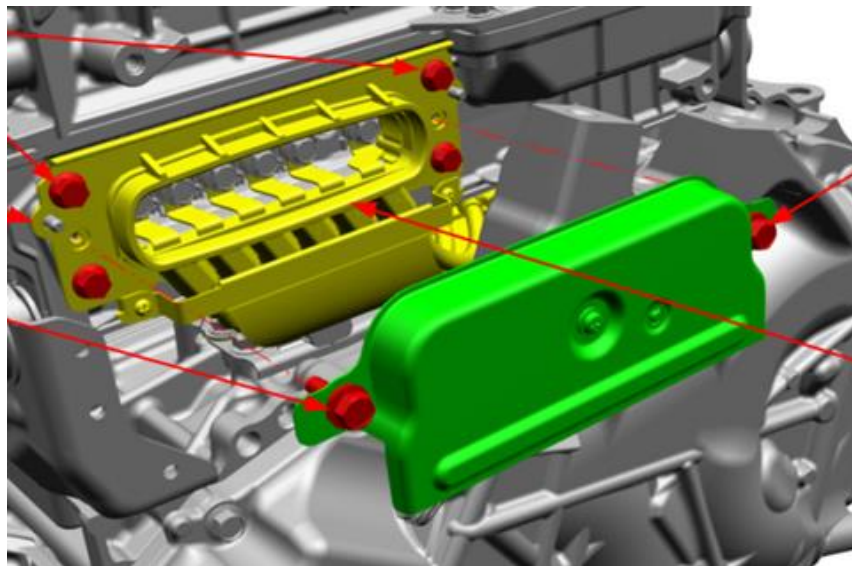
1. Remove the DMPI cable interface cover (Green) and bolts securing the cables.  
**DO NOT USE POWER TOOLS**

Inspect the DMPI connections for signs of cross-threading, damage, loose connections, and metallic debris. Take pictures of any abnormal conditions.

**Repair:** Replace any component which are damaged or found to be outside of specification.

**Note:** Engineering does not advise re-tapping cross-threaded connection joints. If cross-threading is identified, the associated component (Transmission or DMPI) will need to be replaced.

12 Nm - Cables to DMPI

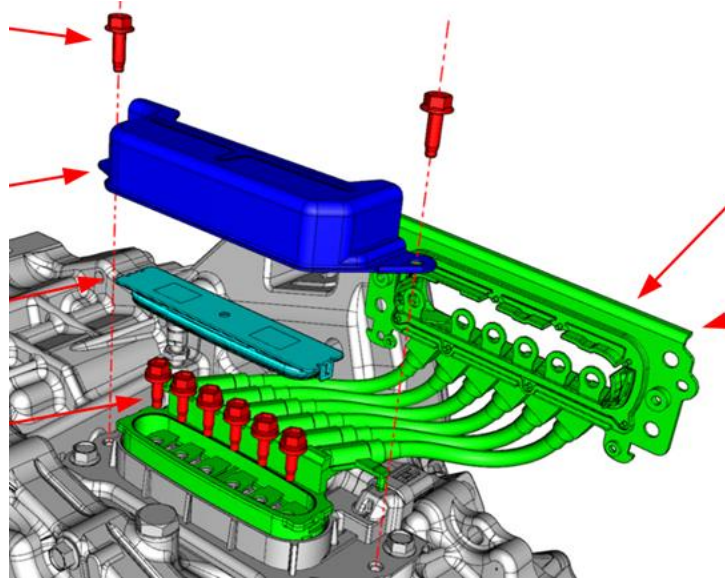
2. Remove the Transmission cable interface cover (Blue) and bolts securing the cables.

Visually inspect the Transmission connections for signs of cross-threading, damage, loose connections, and metallic debris. Take pictures of any abnormal conditions.

8 Nm - Cables to Transmission
