## TECHNICAL SERVICE BULLETIN

**26-2102**14 March  
2026

**Illuminated Yellow/Red ABS Warning Indicator With DTCs C0037:01, C0037:07, C0037:2F, C0037:4A, C0037:64, C003A:01, C003A:07, C003A:2F, C003A:4A, And/Or C003A:64 Stored In The ABS Module**

| <b>Ford</b><br>2025 Mustang GTD | Built on or before 14-Aug-2025 |

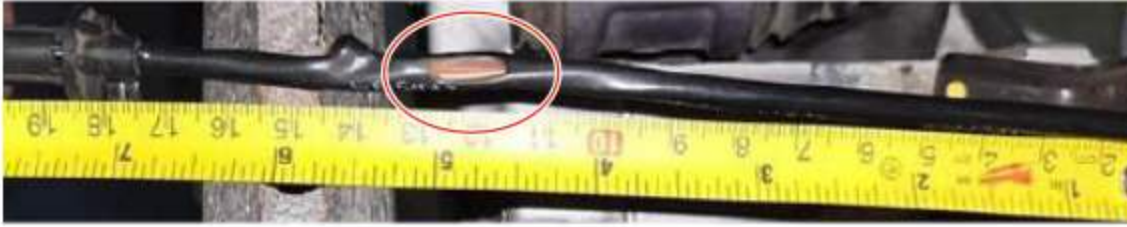
Figure 1

**Issue:** Some of the vehicles listed in the Model statement above may exhibit an Illuminated yellow/red ABS warning indicator with DTCs C0037:01, C0037:07, C0037:2F, C0037:4A, C0037:64, C003A:01, C003A:07, C003A:2F, C003A:4A, and/or C003A:64 stored in the ABS module. This may be due to thermal damage in the heat shield that covers the rear wheel speed sensor wire harness, caused by the heat generated from the rear brake rotors.

1. Does the rear wheel speed sensor(s) show signs of thermal damage similar to those in Figures 1-2?

- (1). Yes - proceed to Step 2.
  - (2). No - this article does not apply. Refer to the WSM, Section 206-09 for normal diagnostics.
- 2.** Replace the affected rear wheel speed sensor(s) with the new, updated part. Refer to WSM, Section 206-09 Anti-Lock Brake System (ABS) and Stability Control > Removal and Installation.
