**Technical Service Bulletin (TSB)**  
**High Pressure Fuel Pump**

| REFERENCE: | TSB: 14-002-26<br>GROUP: 14 - Fuel System | Date: | March 13, 2026 | REVISION: | 14-001-25 |
| VEHICLES AFFECTED: | 2022 - **2026** (B1) Jeep Renegade<br>2022 - **2026** (H1) Jeep Commander<br>2022 - **2026** (M1) Jeep Compass<br>This bulletin applies to vehicles built on and before **March 06, 2026 (MDH 0306XX)** equipped with a 1.3 I4 Turbo MAIR DI Engine (Sales Code EYJ). | | | MARKET APPLICABILITY:<br><div><input type="checkbox"/> NA<input type="checkbox"/> MEA</div> <div><input checked="" type="checkbox"/> SA<input type="checkbox"/> IAP</div> <div><input type="checkbox"/> EE<input type="checkbox"/> CH</div><br>NOTE: **This bulletin applies to the Brazilian market.** | |

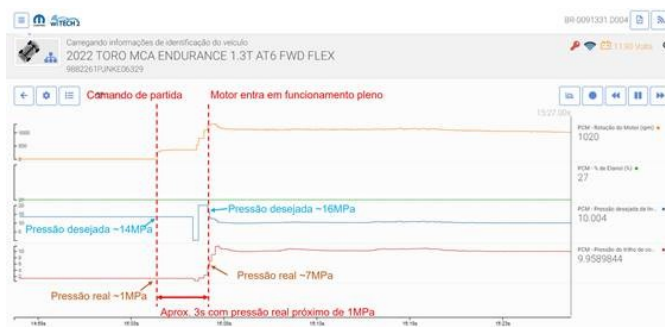
**Fig. 1**

1. Position the vehicle at the workplace.
2. Open the engine hood.
3. Fit the bodyguards (fenders and front bumpers).
4. Run the motor up to the working temperature.
5. Connect wiTECH to the vehicle.
6. Access the injection ramp pressure values in the injection control module (ECM) in graphical mode. To do this, choose the following parameters:
  - Engine speed (or engine speed).
  - Fuel rail pressure (or Fuel pressure instruction on common rail high fuel pressure).
  - Desired Fuel Line Pressure (or Common Fuel Injection Chute Pressure).
7. Observe if the graph read on the vehicle is as shown in the images of the examples below.

Graphical Mode - KO Result

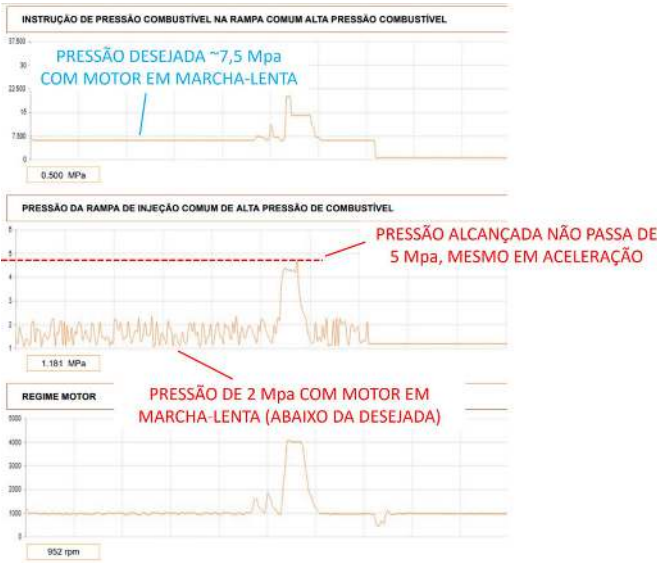
**Fig. 2**  
Engine Start With Failure

8. Monitor wiTECH whether the high-pressure fuel pump will deliver the desired pressure immediately at the time of start-up when the failure occurs:
9. Is there a delay in the pressure increase or does the actual pressure not reach the desired pressure?

Partida do motor de um veículo **COM** falha

- If the pressure measured on the pressure gauge **is between 5.2 and 6.0 bar**, but the rail pressure (injector ramp) measured does NOT follow the desired pressure in the parameters via wiTECH, take a screenshot or PDF print of the screen demonstrating the incident and perform the **INJECTION SYSTEM CLEANING PROCEDURE**.

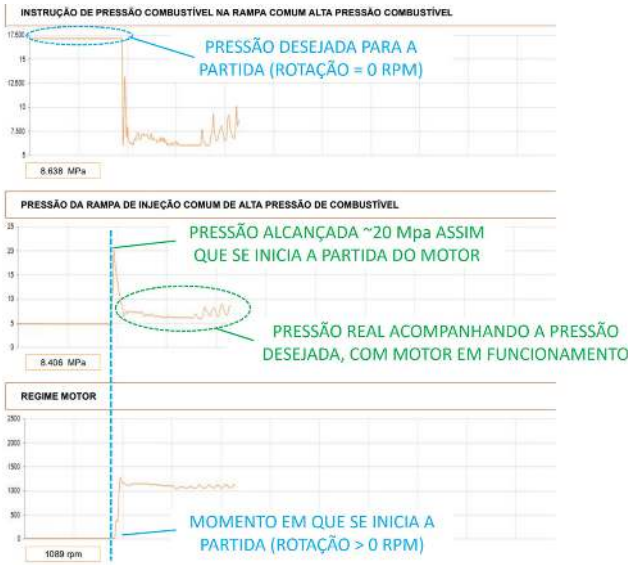
**Fig. 3**  
Engine Start Without Failure

Partida do motor de um veículo **SEM** falha
