**Technical Service Bulletin (TSB)**  
**Fuel Injector Leak**

| REFERENCE: | TSB: 14-003-26<br>GROUP: 14 - Fuel System | Date: | March 13, 2026 | REVISION: | 14-009-25 REV. D |
| VEHICLES AFFECTED: | 2022 - **2026** (B1) Jeep Renegade<br>2022 - **2026** (H1) Jeep Commander<br>2022 - **2026** (M1) Jeep Compass<br>This bulletin applies to vehicles equipped with a 1.3L I4 Turbo MAIR DI Engine w/ESS E100 (Sales Code EYJ). | | | MARKET APPLICABILITY:<br><div><input type="checkbox"/> NA<input type="checkbox"/> MEA</div> <div><input checked="" type="checkbox"/> SA<input type="checkbox"/> IAP</div> <div><input type="checkbox"/> EE<input type="checkbox"/> CH</div><br>NOTE: This bulletin applies to the **Brazilian** market. | |

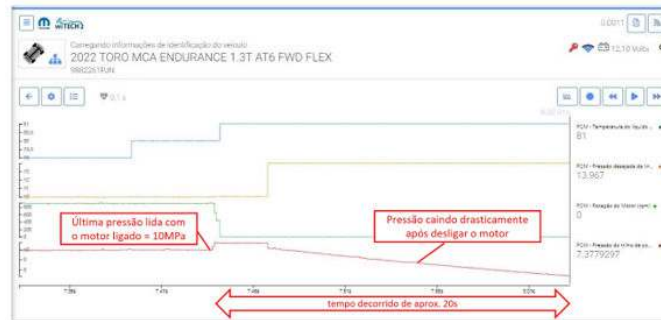
**Fig. 1**  
Leak Test - KO Result

- Did the leak test results according to the images in the examples above?
  - YES >>> Do not apply this TSB.
  - NO >>> Print or capture the image (print screen) showing the injection ramp pressure loss failure with the parameters "Fuel rail pressure" and "Desired fuel line pressure" (for possible warranty submission) and proceed to the next step.
- Open the hood and place the bodyguards on the fenders and front bumper.
- With the engine off, still at working temperature, remove the spark plugs, according to operation "5510D10 - Spark plugs - Removal and Replacement".

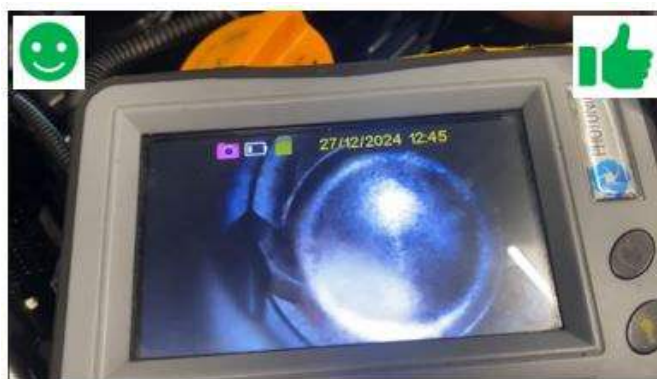
**Fig. 4**

OK Injector - No leakage

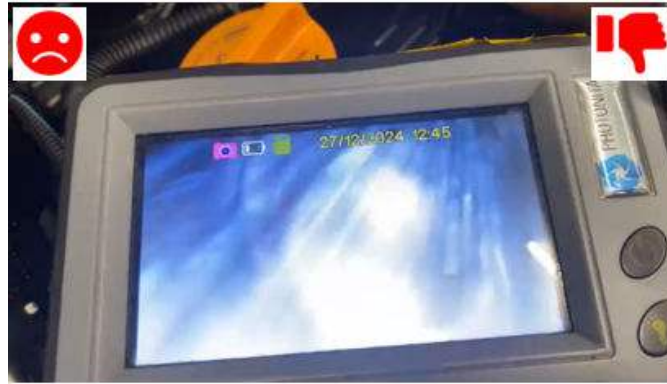
**Fig. 5**

Injector KO - Leaking

17. Was a leak found through the tip of any of the injectors [Fig. 5](#)?

- YES >>> Carry out the **REPAIR PROCEDURE**.
- NO >>> Perform the **INJECTION SYSTEM CLEANING PROCEDURE**. \*\*

1. **\*\*Replace the fuel injector(s) as required if defective and the fuel tube (rail / high pressure pump).**  
Refer to the detailed service procedures available in DealerCONNECT/Service Library under: Service Info> 1056F60 - Tubo Coletor de Combustível Único - Completo de Eletroinjeter Remoção/Recolocação.

- If only one injector is defective, replace one injector and the fuel tube (rail / high pressure pump).
- If two injectors are defective, replace only the two defective injectors and the fuel tube (rail / high pressure pump).
- If three or all four injectors are defective, replace all four defective injectors and the fuel tube (rail / high pressure pump).
