| REFERENCE: | TSB: 08-110-26 REV. A<br>GROUP: 08 - Electrical | Date: | March 14, 2026 | REVISION: | 08-110-26 |
| VEHICLES AFFECTED: | 2024 (LB) Dodge Charger<br>This bulletin applies to vehicles equipped with 400V G2500 FR/RR Elec Drive Motors (Sales Code ELD). | | | MARKET APPLICABILITY:<br><input checked="" type="checkbox"/> NA <input type="checkbox"/> MEA<br><input type="checkbox"/> SA <input type="checkbox"/> IAP<br><input type="checkbox"/> EE <input type="checkbox"/> CH<br><br>NOTE: This bulletin applies to the North America markets. | |

| <b>CAUSE:</b> | <b>BPCM software update</b> |

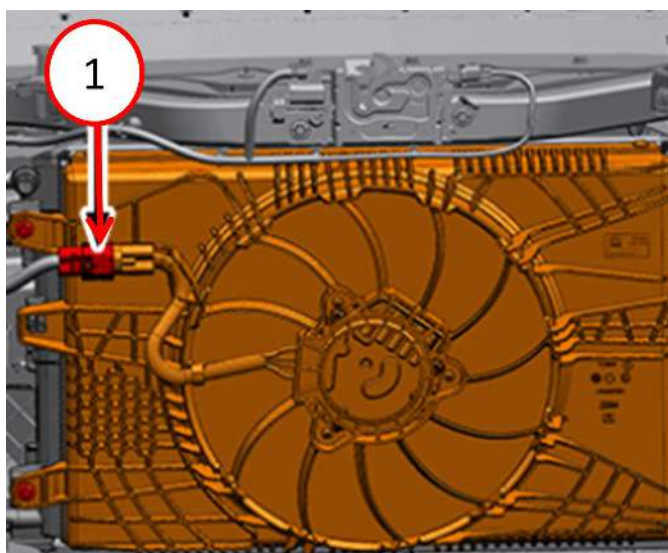
**Fig. 1**  
Cooling Fan Assembly

**NOTE: The cooling fan must be disconnected to prevent it from powering on, which may interrupt/ abort the flash process.**

1 - Wire Harness To Disconnect/Connect

4. Disconnect the cooling fan wire harness connector [Fig. 1](#).

35. Install the #38 AGSM fuse [Fig. 3](#) and the PDC cover [Fig. 2](#).
36. Position the rear carpet in place.
37. Connect the cooling fan wire harness connector [Fig. 1](#).
38. Install the front storage bin. Refer to the detailed service procedures available in DealerCONNECT/ServiceLibrary under: Service Info> 23 - Body / Exterior / Bin, Storage / Installation.
39. Perform 10 vehicle sleep cycles by completing the following:
  - With all doors, frunk and trunk closed, Micropod unplugged and the ignition in the Off position, wait for **PRNDL light to go off. Wait three minutes.**
  - Place the ignition in the On position.
  - Repeat this process nine times.
40. Clear any DTCs that may have been set in any modules due to reprogramming. The wiTECH application will automatically present all DTCs after the flash and allow them to be cleared.

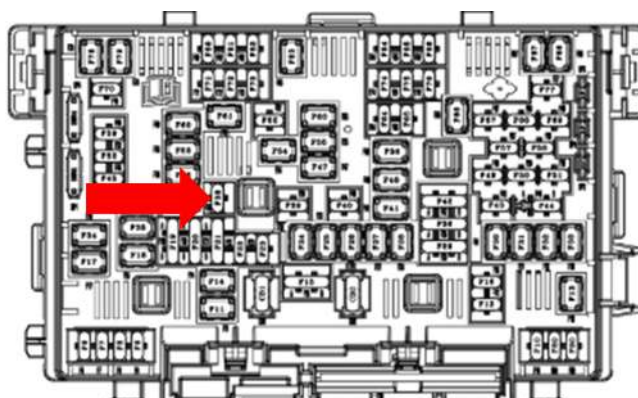
**Fig. 3**  
#38 AGSM Fuse Location

**Failure to remove the #38 AGSM fuse will result in damage to the shifter.**

6. Remove the PDC cover, locate and remove the #38 AGSM fuse [Fig. 3](#).

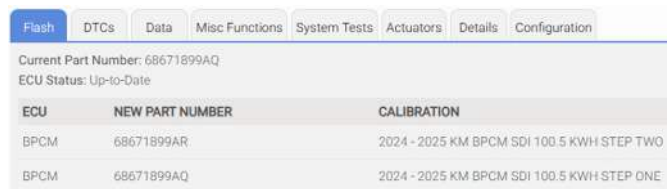
**Fig. 4**

There will not be a lightening bolt present for the BPCM to be reprogrammed due to some vehicles requiring two updates. The software level must be inspected before reprogramming to ensure the proper update steps are followed.

Two Step Software Level AR And AQ Screen

7. Inspect the software level on the BPCM by going into the "Flash" tab and compare to what software is available [Fig. 4](#).

If the BPCM is already at the AQ level, the module must be reprogrammed to the AR level. Do not over flash at the AQ level to get to the AR level.
