| REFERENCE: | TSB: 08-011-26 REV. A<br>GROUP: 08 - Electrical | Date: | March 17, 2026 | REVISION: | 08-011-26 |
| VEHICLES AFFECTED: | 2025 (WL) Jeep Grand Cherokee / Grand Cherokee L<br>This bulletin applies to vehicles equipped with a Global Telematics Box Module (Sales Code RDG). | | | MARKET APPLICABILITY:<br><div><input checked="" type="checkbox"/> NA<input type="checkbox"/> MEA<br/><input type="checkbox"/> SA<input type="checkbox"/> IAP<br/><input type="checkbox"/> EE<input type="checkbox"/> CH</div><br><b>NOTE:</b> This bulletin applies to the North America market. | |
| CAUSE: | TBM Software | | | | |

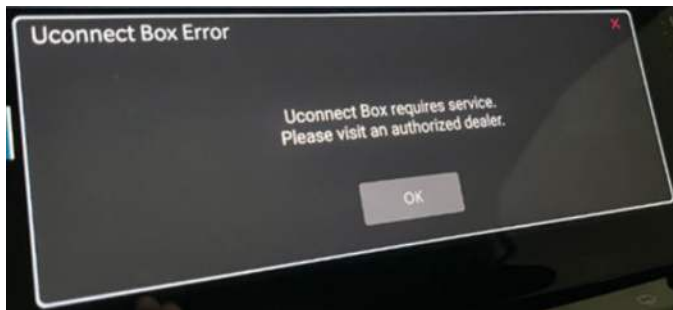
**Fig. 1**  
Uconnect Box Requires Service

**NOTE:** This message can be triggered by different reasons **Fig. 1**. For an issue on a new vehicle recently switched to customer mode, please follow the New Vehicle Preparation procedure to resolve the issue. For the customer vehicle with intermittent concerns, please check the TBM, antenna and instrument panel harness connections.

This bulletin involves reprogramming the TBM with the latest available software.

1. Reprogram the TBM with the latest software. If issues arise when flashing a module using the wiTECH Diagnostic Application, please submit a ticket to the Helpdesk. The helpdesk can be found within the Help menu.
2. Clear all DTCs that may have been set in any module due to reprogramming. The wiTECH application will automatically present all DTCs after the flash and allow them to be cleared.
