## Technical Service Bulletin (TSB)

### Coolant Temperature Sensor Malfunction

| REFERENCE: | TSB: 08-115-26<br>GROUP: 08 - Electrical | Date: | March 18, 2026 | REVISION: | — |
| VEHICLES AFFECTED: | 2024 - 2025 (H6) Jeep Meridian<br>2024 - 2025 (M6) Jeep Compass<br>This bulletin applies to vehicles built on or after November 01, 2025 (MDH 1101XX) and on or before February 16, 2026 (MDH 0216XX) equipped with the 2.0L I4 Turbo Diesel Engine w/ ESS (Sales Code EBS). | | | MARKET APPLICABILITY:<br><div><input type="checkbox"/> NA<input type="checkbox"/> MEA</div> <div><input type="checkbox"/> SA<input checked="" type="checkbox"/> IAP</div> <div><input type="checkbox"/> EE<input type="checkbox"/> CH</div><br><b>NOTE:</b> This bulletin applies to India & Asia Pacific markets. | |

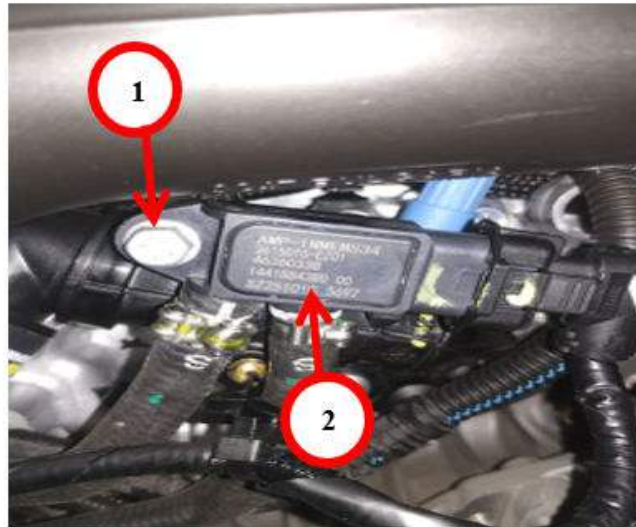
**Fig. 1**  
DPF Sensor Removal

1 - DPF Sensor Bolt  
2 - DPF Sensor

2. Remove the Diesel Particulate Filter (DPF) pressure sensor bolt [Fig. 1](#).

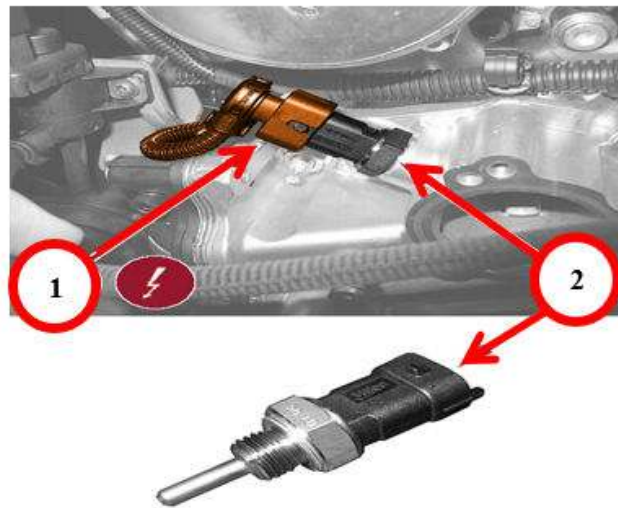
**Fig. 2**  
ECT Sensor Removal

1 - ECT Sensor Wire Harness Connector  
2 - ECT Sensor

3. Position aside the DPF pressure sensor.
4. Disconnect the ECT sensor wire harness connector [Fig. 2](#).

5. Remove the ECT sensor [Fig. 2](#).
6. Inspect the ECT sensor batch code located on the brass nut [Fig. 3](#).

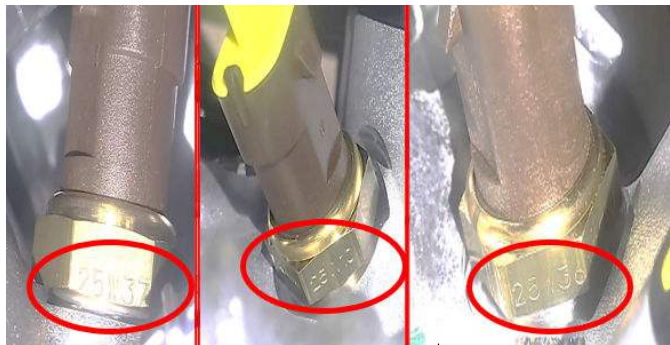
**Fig. 3****ECT Sensor Batch Code Location**

| CAUSE: | Engine Coolant Temperature (ECT) sensor is not properly soldered | | | | |

7. Does the batch code on the brass ETC sensor matching any of the following batch code numbers listed below?
  - 25W10
  - 25W36
  - 25W37
  - YES>>> Proceed to [Step 8](#).
  - NO>>> This bulletin has been completed. Use Inspection LOP (08-14-20-9A) to close the active RSU and proceed to [Step 9](#)
8. Obtain a **NEW** ECT sensor.
9. Install the ECT sensor and tighten the ECT sensor bolt to 22 N·m (16 ft. lbs.).
10. Install the DPF pressure sensor and tighten the sensor bolt to 9 N·m (80 in. lbs.) [Fig. 4](#).

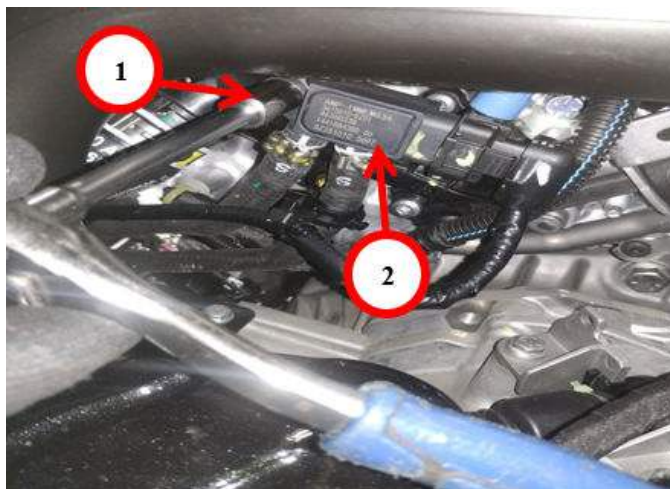
**Fig. 4****Install DPF Pressure Sensor**

- 1 - Tighten DPF Pressure Sensor Bolt  
2 - DPF Pressure Sensor
