## STAR ONLINE PUBLICATION

**Case Number:** S2219000004 Rev. A

**Models Affected:** 2022-2026 Jeep Wagoneer (WS).

**Symptom/Vehicle Issue:** Service Electric Power Steering Message On Cluster.  
C0051-54 Steering Wheel Position Sensor Calibration, C0051-64 Steering Angle Set.

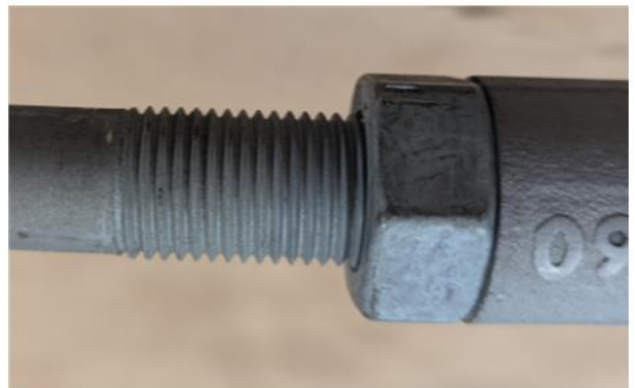
Fig 1 Fig 2.

**<<<Note>>>** This condition may have happened during service work or possibly a minor collision like wheel contact with a curb. A visual symptom of the issue could be the tie rod adjusters exhibit uneven exposed thread count as shown below (Fig 1 and Fig 2). If this exists- continue with the below inspection.

Left and Right Outer Tie Rod Adjustment Uneven Thread Count.

3. If the tie rod adjusters have a significant visual difference in exposed threads (Fig 1, Fig 2) perform a toe alignment and verify the steering wheel position is straight.
4. Install the driver air bag and any trim removed prior.
5. Test drive the vehicle to confirm customer complaint is resolved.
