| <br><b>Technical Service Bulletin</b> | <b>GROUP</b><br><b>ADAS</b> | <b>NUMBER</b><br><b>26-AD-001G</b> |
| <b>SUBJECT:</b> FRONT VIEW CAMERA WARNING AND CALIBRATION<br>(DTC C272246) | | |

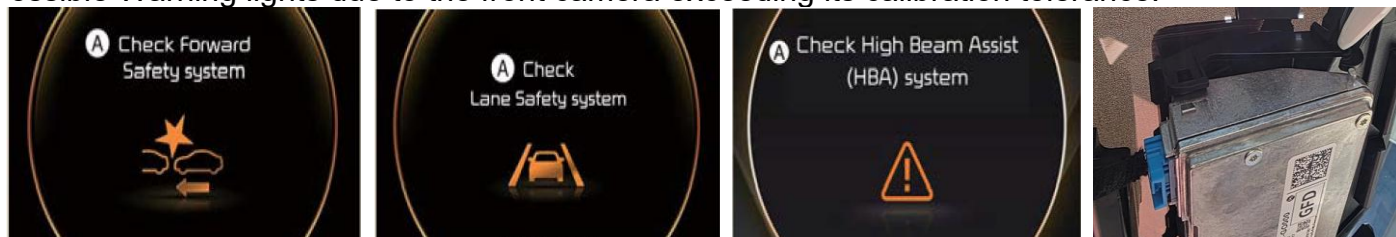
Possible Warning lights due to the front camera exceeding its calibration tolerance:

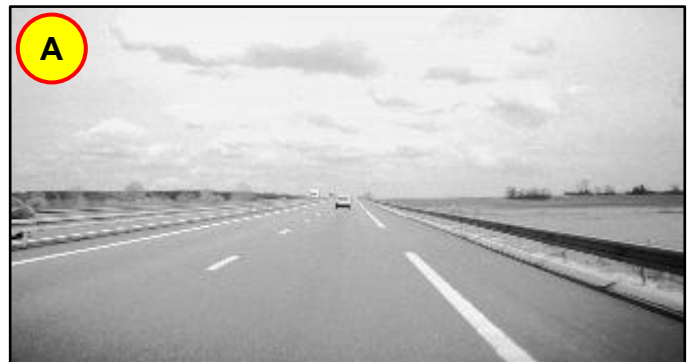
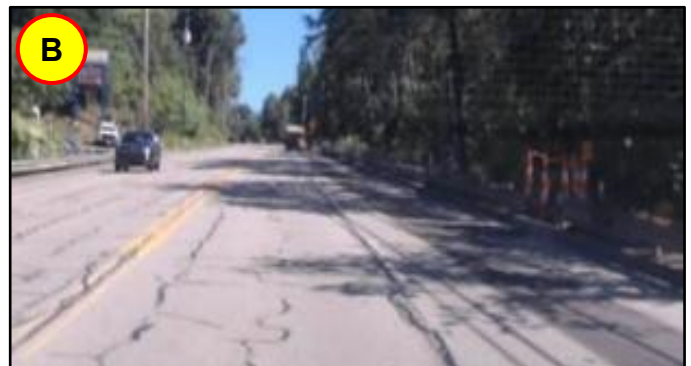
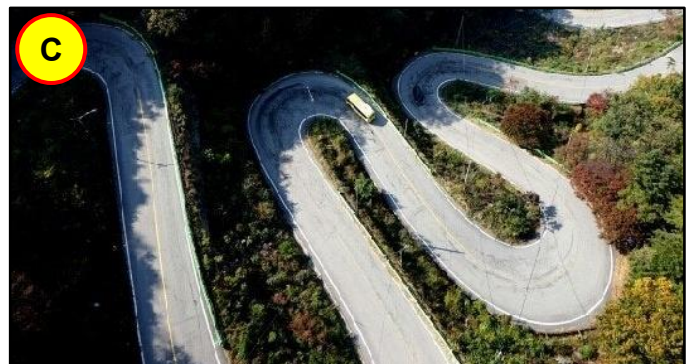
Calibration may fail when conducted on a road with too much surface damage (B) or too many curves (C).

2. Confirm and if necessary, address the concern for the possibility of the following conditions:
  - Remove and re-install the front camera in case it was seated improperly.
  - Check all tires pressure, ensuring they are set to specification.
  - Ensure there is no excessive load on one side of the vehicle.
  - Ensure the vehicle is not leaning too much in the front end or rear end due to excessive load.
3. Test drive the vehicles under the following conditions:
  - Time: **5 minutes**
  - Speed: Over **18.6 MPH (30 KPH)**
  - Road: Straight with minimal curves (A)
