| ELE | 2022-2025MY<br>Multiple Models |
| 394 | March 2026 |

## TECHNICAL SERVICE BULLETIN

### AVN5.0W DTC P17A000 DAIGNOSTIC PROCEDURE

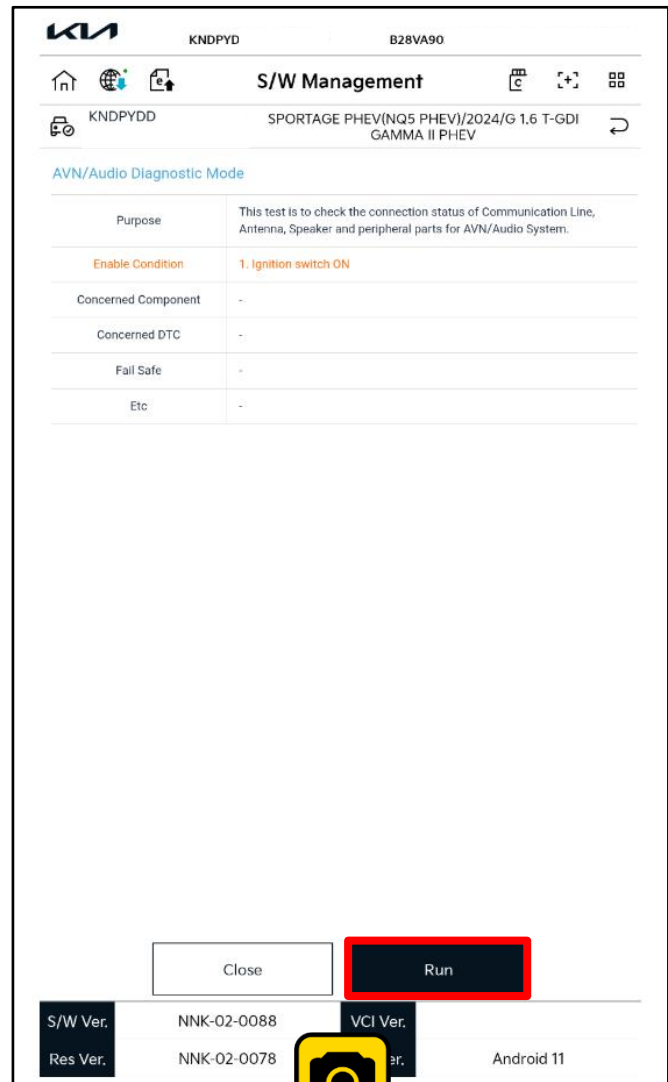
3b. Confirm if DTC **B283700** is stored.

B282600 - GPS Antenna Short State  
 B282700 - GPS Antenna Open State  
 B28C000 - Am/Fm Radio Antenna Short State  
 B28C100 - Am/Fm1 Radio Antenna Short State  
 B28C600 - Roof LTE/3G Antenna Short State  
 B28C700 - Roof LTE/3G Antenna Open State  
 B28C900 - C/PAD LTE antenna Short State  
 B28CA00 - C/PAD LTE antenna Open State

- DTC is NOT stored (**OK**), then proceed to step 3c.
- DTC IS stored (**NG**), proceed to step 3c, then **replace** the AVN5.0W Head Unit by referring to 'AVN5.0W Head Unit Replacement Procedure' on page 9. Using KDS Tablet **Warranty Claim Attachment** Tab, take a photo of the stored B283700 DTC.

- DTC(s) is/are NOT stored (**OK**), then proceed to step 4.
- DTC(s) IS/ARE stored (**NG**), then **replace** the Antenna by referring to the 'Antenna Replacement Procedure' on page 10. Using KDS Tablet **Warranty Claim Attachment** Tab, take a photo of the stored DTC.

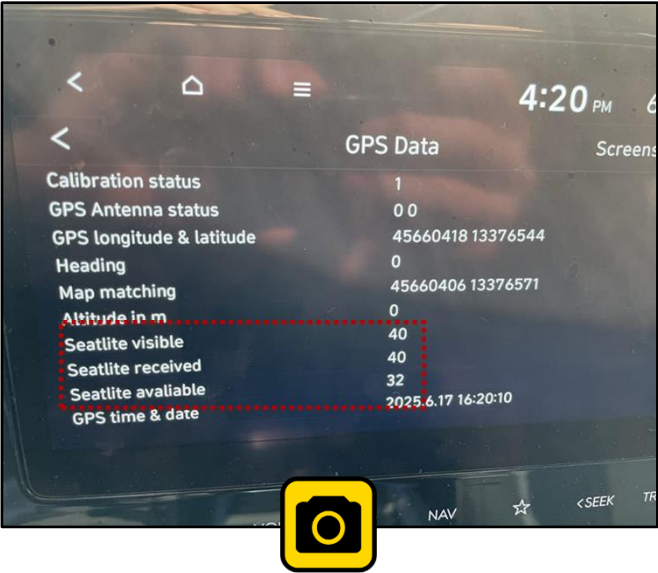
9. Confirm the 'Satellite visible', 'Satellite received', and 'Satellite available' are within specification.

| Satellite visible, received and available Values | |
| When Vehicle is <u>INDOORS</u> | ≥ 5 |
| When Vehicle is <u>OUTDOORS</u> | ≥ 15 |

- Satellite visible, received AND available **ARE ALL** within specification (OK), then proceed to step 10.
- Satellite visible, received AND available are **NOT** within specification (NG), then proceed to the 'Antenna Replacement Procedure' on page 10. Using KDS Tablet [Warranty Claim Attachment](#) Tab, take a photo of the Satellite visible, 'Satellite received', and 'Satellite available' values.
