## Technical Service Bulletin (TSB)

### Coolant Temperature Sensor Malfunction

| REFERENCE: | TSB: 08-115-26 REV. A<br>GROUP: 08 - Electrical | Date: | March 25, 2026 | REVISION: | 08-115-26 |
| VEHICLES AFFECTED: | <b>**2025 - 2026** (H6) Jeep Meridian</b><br><b>**2025 - 2026** (M6) Jeep Compass</b><br>This bulletin applies to vehicles built on or after November 01, 2025 (MDH 1101XX) and on or before <b>**March 20, 2026 (MDH 0320XX)**</b> equipped with the 2.0L I4 Turbo Diesel Engine w/ ESS (Sales Code EBS). | | | <b>MARKET APPLICABILITY:</b><br><div><input type="checkbox"/> NA<input type="checkbox"/> MEA</div> <div><input type="checkbox"/> SA<input checked="" type="checkbox"/> IAP</div> <div><input type="checkbox"/> EE<input type="checkbox"/> CH</div><br><b>NOTE:</b> This bulletin applies to India & Asia Pacific markets. | |

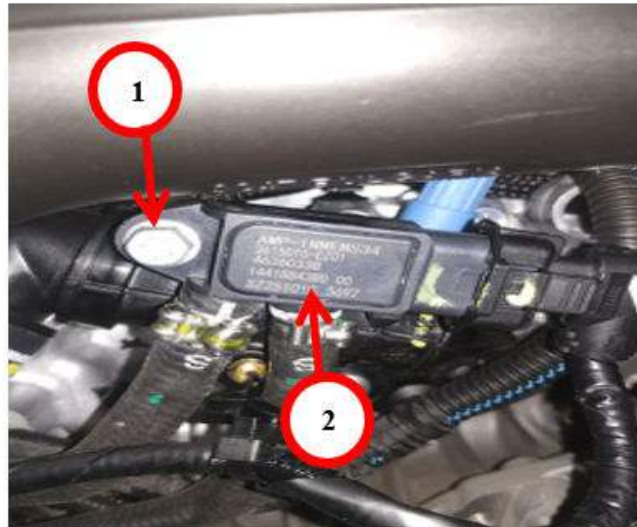
**Fig. 1**  
DPF Sensor Removal

1 - DPF Sensor Bolt  
2 - DPF Sensor

2. Remove the Diesel Particulate Filter (DPF) pressure sensor bolt [Fig. 1](#).

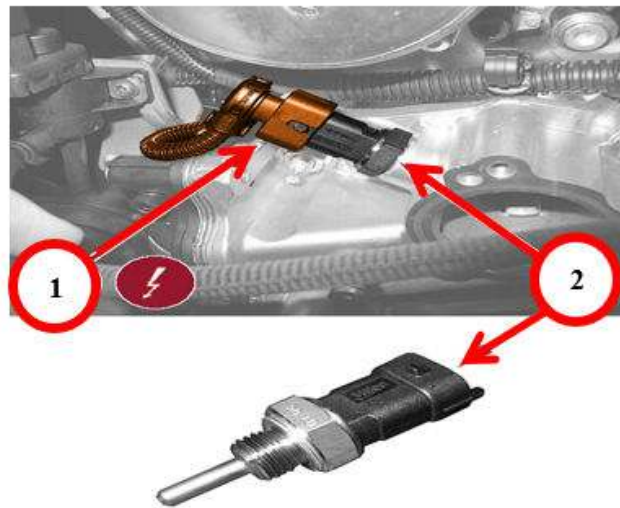
**Fig. 2**  
ECT Sensor Removal

1 - ECT Sensor Wire Harness Connector  
2 - ECT Sensor

3. Position aside the DPF pressure sensor.
4. Disconnect the ECT sensor wire harness connector [Fig. 2](#).

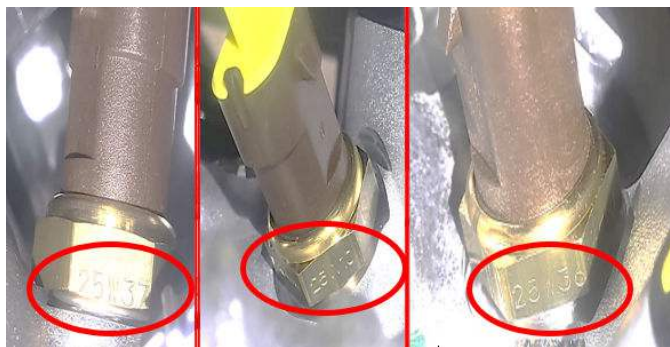
**Fig. 3****ECT Sensor Batch Code Location**

| CAUSE: | Engine Coolant Temperature (ECT) sensor is not properly soldered | | | | |

5. Remove the ECT sensor [Fig. 2](#).
6. Inspect the ECT sensor batch code located on the brass nut [Fig. 3](#).

7. Does the batch code on the brass ETC sensor matching any of the following batch code numbers listed below?
  - 25W10
  - 25W36
  - 25W37
  - YES>>> Proceed to [Step 8](#).
  - NO>>> This bulletin has been completed. Use Inspection LOP (08-14-20-9A) to close the active RSU and proceed to [Step 9](#)
8. Obtain a **NEW** ECT sensor.
9. Install the ECT sensor and tighten the ECT sensor bolt to 22 N·m (16 ft. lbs.).
10. Install the DPF pressure sensor and tighten the sensor bolt to 9 N·m (80 in. lbs.) [Fig. 4](#).

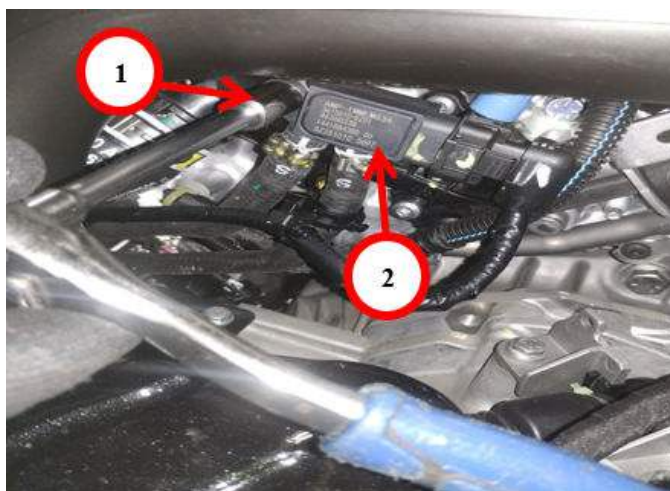
**Fig. 4****Install DPF Pressure Sensor**

- 1 - Tighten DPF Pressure Sensor Bolt  
2 - DPF Pressure Sensor
