### Check engine light or Adblue warning with fault codes P206B31, P203B31, or P300494 present in AdBlue (SCR) control unit (N118/5)

| Topic number | LI49.20-N-078838 |
| Function group | 49.20 - Exhaust gas aftertreatment |
| Validity | Model 907 |

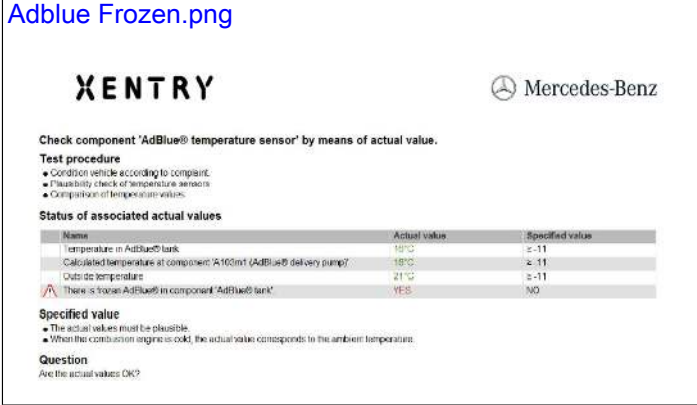
| File | Description |
|---|---|
| <p><a href="#">Adblue Frozen.png</a></p> | Adblue Frozen |

C. Frozen or partially frozen AdBlue can cause the AdBlue level and concentration functions to report inaccurate values.

If XENTRY still indicates frozen AdBlue or the concentration remains inaccurate after drain and refill and the thaw, mix, retest requirements were completed, proceed to section D.

1. Check if AdBlue is frozen. If frozen, allow the vehicle to sit in a warm environment overnight and recheck.
2. With the vehicle running and XENTRY connected, display the actual AdBlue level values.
3. Drain the AdBlue tank and verify the displayed fill level reflects the change.
4. Fill the AdBlue tank slowly. Do not overfill. Verify the fill level reflects the change.

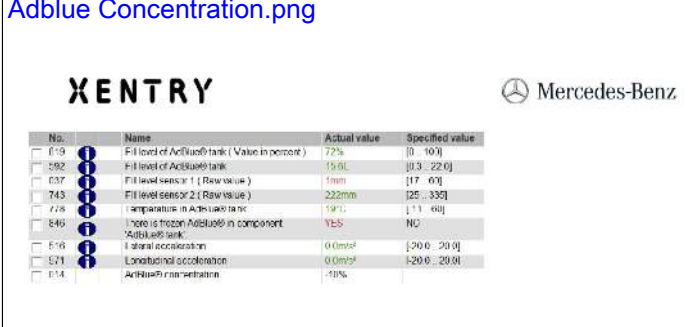
| File | Description |
|---|---|
| <p><a href="#">Adblue Concentration.png</a></p> | Adblue Concentration |

B. The AdBlue concentration is outside ISO 22241 limits (below 31.8 percent or above 33.2 percent).

1. Confirm full thaw and mixing per LI49.20-N-080376, then verify AdBlue concentration.
  - a. Check concentration using the MB refractometer per the MB tool instructions and applicable WIS guidance.
  - b. Use freeze frame data when applicable.
2. If AdBlue concentration remains below 31.8 percent or above 33.2 percent after full thaw, mixing drive, and retest, AdBlue replacement is required.

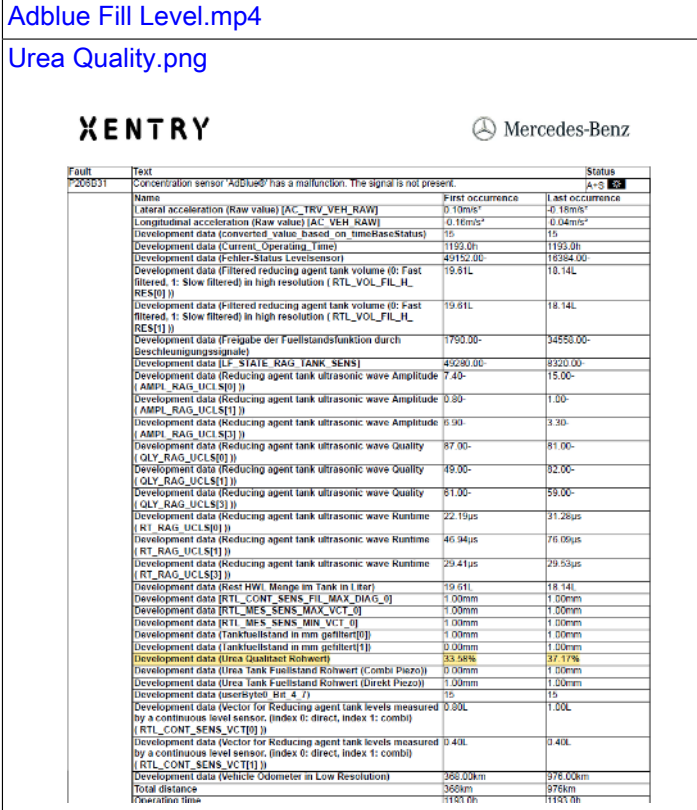
| File | Description |
|---|---|
| <p><a href="#">Urea Quality.png</a></p> | Urea Quality |

P300494 The quality of the AdBlue is insufficient.
