# Service Alert

INFOTAINMENT CENTER DISPLAY AND CONNECTED VEHICLE  
IMPROPER OPERATION

Service Alert No.: SA-015/26

2026 CX-5 (KM)

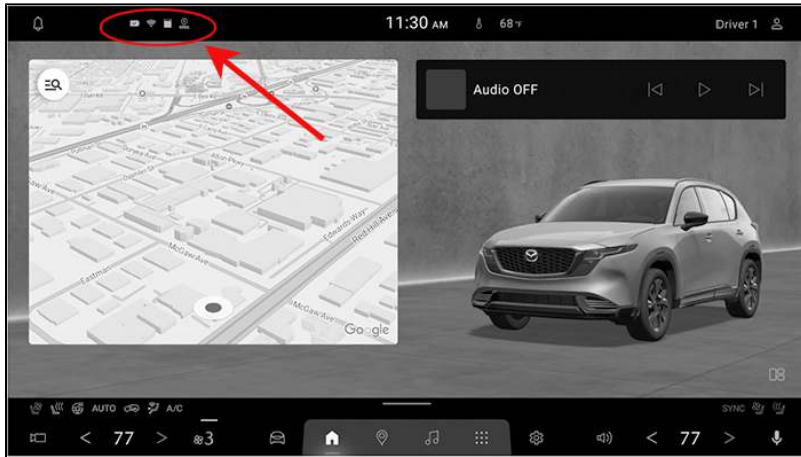
1. Intermittent Globe with a slash icon

- The Globe with Slash icon indicates that communication between the Cockpit Domain Controller (CDC) and the Data Communication Module (DCM) has not yet been completed.
  - This communication may take up to 90 seconds to complete. During this time, some Mazda Connect 3 functions, such as Google Assistant, will not be available.
  - Once communication is complete, the Globe with Slash icon will be replaced by the reception icon, as shown below.

- If communication between the CDC and DCM does not complete within 90 seconds, the system has experienced an interruption. Advise the customer that Mazda is aware of the condition and is currently working on a resolution. As soon as a resolution becomes available, this Service Alert will be promptly updated and re-released.
  - **NOTE:** Vehicle driving operation is not affected during this condition.

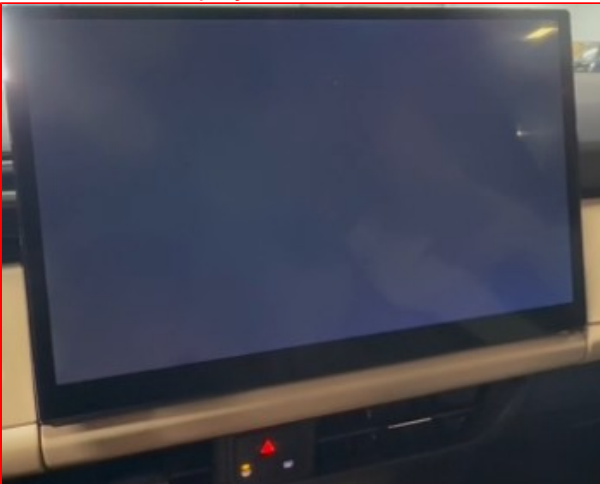
### 4. The center display screen is blank

- This condition is related to Item 1 above. Advise the customer that Mazda is aware of the condition and is currently working on a resolution. As soon as a resolution becomes available, this Service Alert will be promptly updated and re-released.

**NOTE:** The rear view camera display while in "Reverse" remains operational during this condition.

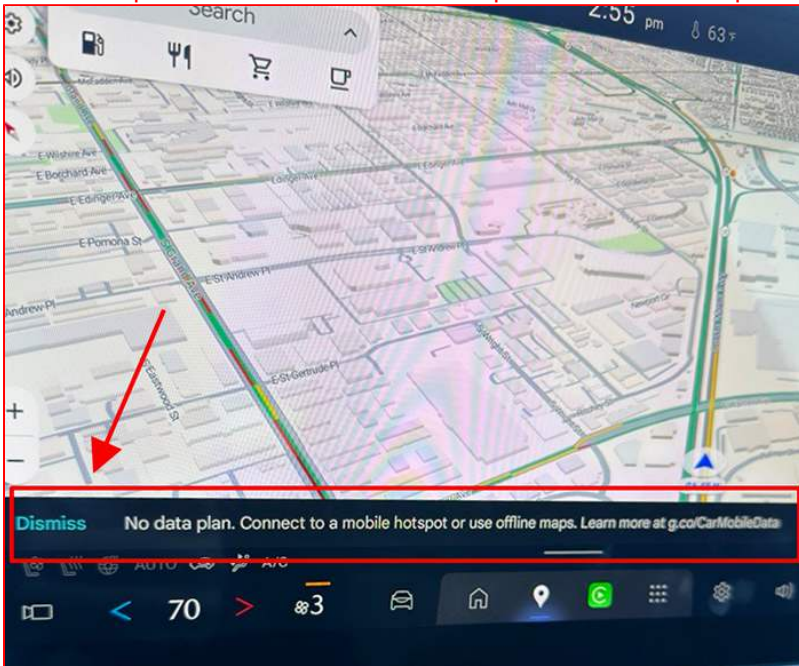
5. No data plan. Connect to a mobile hotspot or use offline maps. learn more at [g.co/CarMobileData](https://g.co/CarMobileData) message

- This message is incorrect.
- It does not affect system operation.
- Dismissing the message may temporarily clear it.
- Please ignore this message at this time.
- This condition is related to Item 1 above. Advise the customer that Mazda is aware of the condition and is currently working on a resolution. As soon as a resolution becomes available, this Service Alert will be promptly updated and re-released.

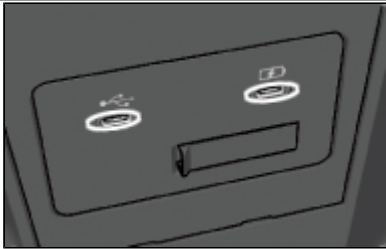
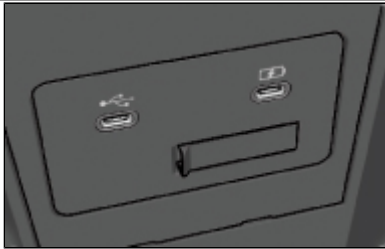
| LED's On<br>The vehicle is not in sleep mode | LED's Off<br>The vehicle is in sleep mode |

- After several minutes of driving.
- After Ignition OFF, **close doors/trunk/liftgate/hood** and wait approximately 3 minutes **to put the vehicle in sleep mode**, then turn ignition back ON.
  - **Sleep mode can be confirmed by monitoring USB-C port LED's. LED's are off when in sleep mode.**
