# Technical product information

| Topic | Engine Coolant Bypass Valve Control Fault - DTC P268100 with symptom code 32827 evident in address 00C5 |
| Transaction No. | 2081300/1 |

## Continental GT/GTC

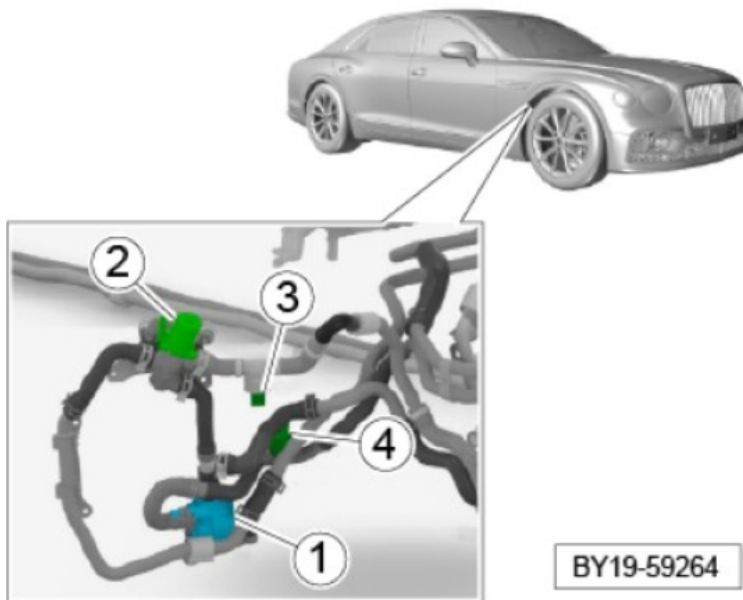
**Figure 1.** *Coolant Pump Solenoid Valve N91 location*

*The coolant pump solenoid valve 4 "(N91)" -2- is located within the front right wheel arch. Disregard all other positions, image for illustration purposes only.*
