## Technical Service Bulletin

Transaction No.: **2070915/2**

01 loose engine oil filler cap - P006800, P227900, P050700 - 2.0 ltr. TFSI

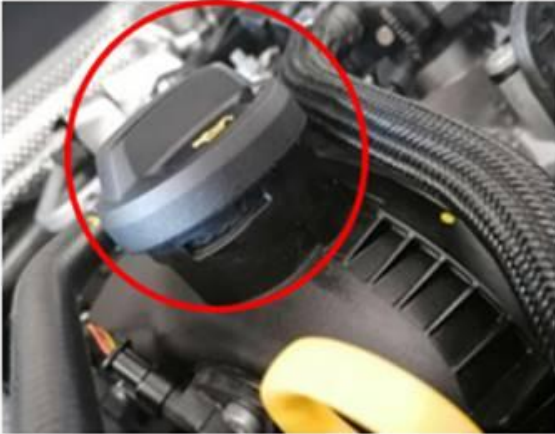
Possibly caused by an incorrectly installed oil filler cap.

**Figure 1.** An incorrectly installed oil filler cap.

Insert the oil filler cap in the correct position. Before inserting the cap, thoroughly clean the contact surfaces of the cap and filler neck.

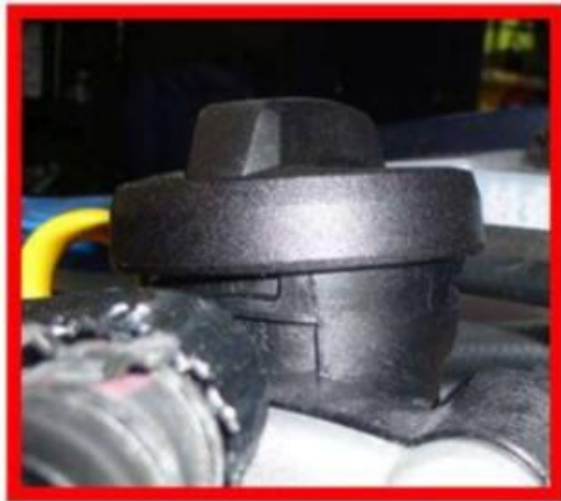
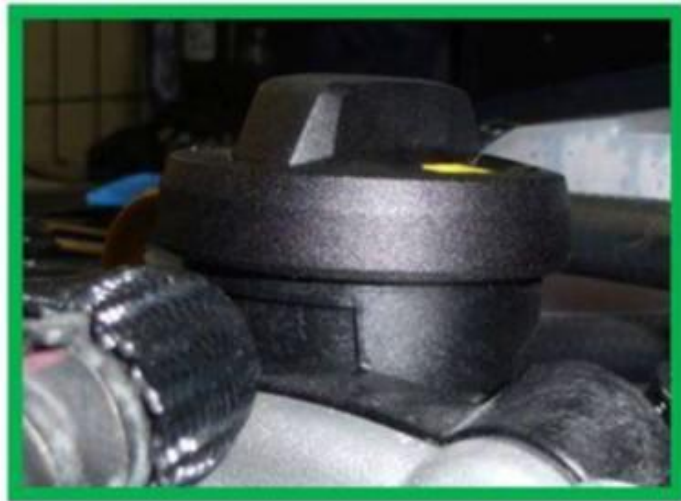
**Figure 2.** The image bordered in red is an incorrectly installed oil filler cap; a correctly installed oil filler cap is bordered in green.
