## Technical Service Bulletin

Transaction No.: **2076994/7**

27 Valeo 48V starter generator (BSG) DTC P0A1A00 P19F800 P0A1E00 U014600  
U300100 P10F300 P056200 P056100 P065200 P069800

Release date: Mar 20, 2026

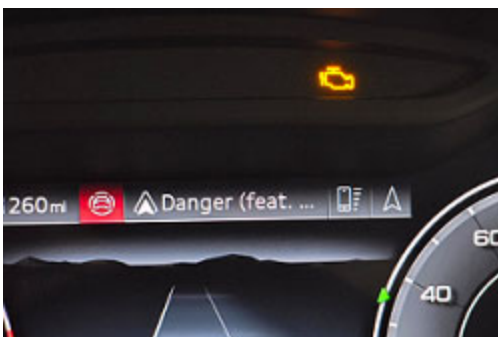
- The engine warning lamp (MIL) is on (Figure 1).

**Figure 1.** MIL is illuminated.
