## Technical Service Bulletin

Transaction No.: **2081184/1**

97 Engine warning lamp lights up, event memory U366500, P2D8800 or P2D8B00 logged in thermal management control unit

| Model(s) | Year(s) | VIN Range | Vehicle Specific Equipment |
|---|---|---|---|
| Q5, Q5 Sportback, SQ5, SQ5 Sportback (GU) | 2025 | All | Not applicable |

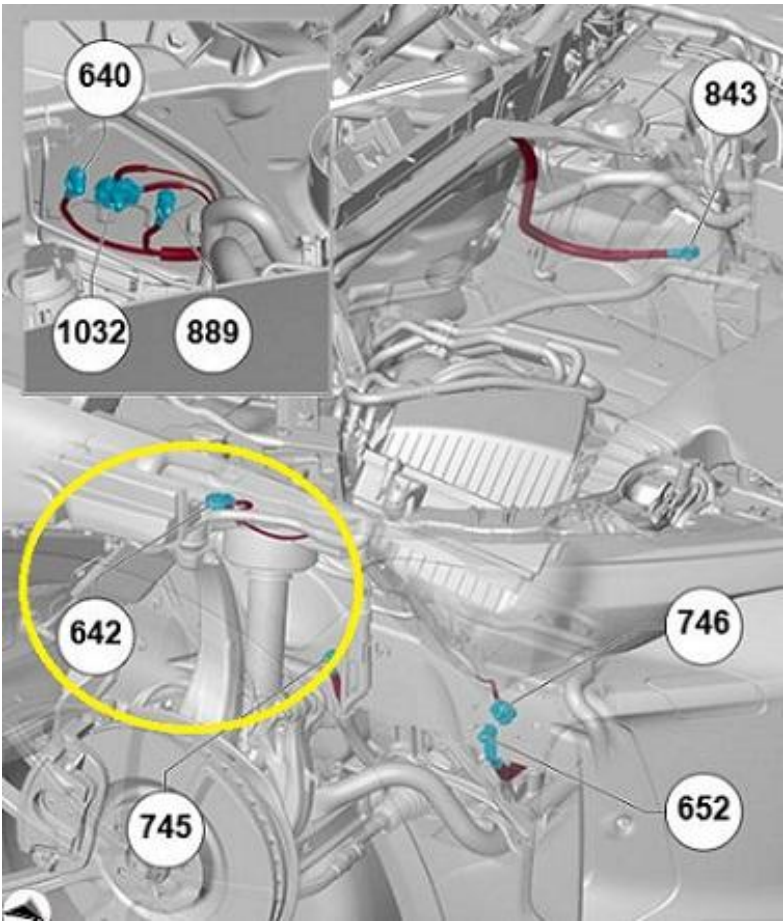
On vehicles manufactured within a specific period, the earth connection at earth point 642 for electrically controlled fan was fitted incorrectly.

Figure 1. Earth point 642 is circled in yellow.

Check earth point 642 for electronically controlled fan (front right) for damage or other issues (refer to yellow oval in image).
