## STAR ONLINE PUBLICATION

**Case Number:** S2508000036 REV. E

**Symptom/Vehicle Issue:** The Occupant Restraint Controller (ORC) Sets B2204-00 Unknown Status (Pending), Sets B2204-00 ECU Configuration Mismatch Or/And DTC B222D-00 Active for ECU Unable to Configure/Configuration Not Learned

**Models:** 2025 RAM (DJ,DD,D2,DP)  
2026 - Grand Cherokee (WL)  
2024 - 2025 Wagoneer S (KM)  
2024 - 2025 Charger (LB)

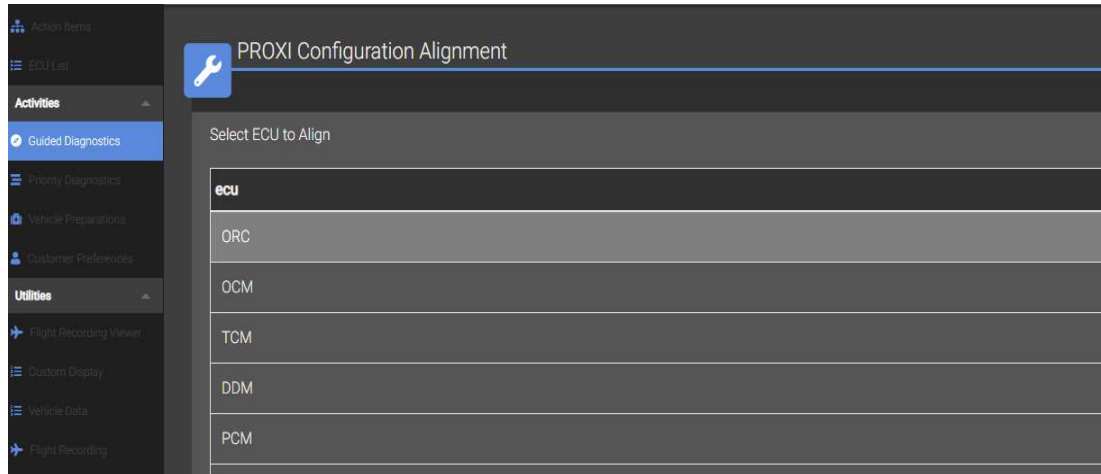
### 1- In Guided Diagnostics, Perform “PROXI Configuration Alignment”

### Select ORC and click Continue to perform the alignment

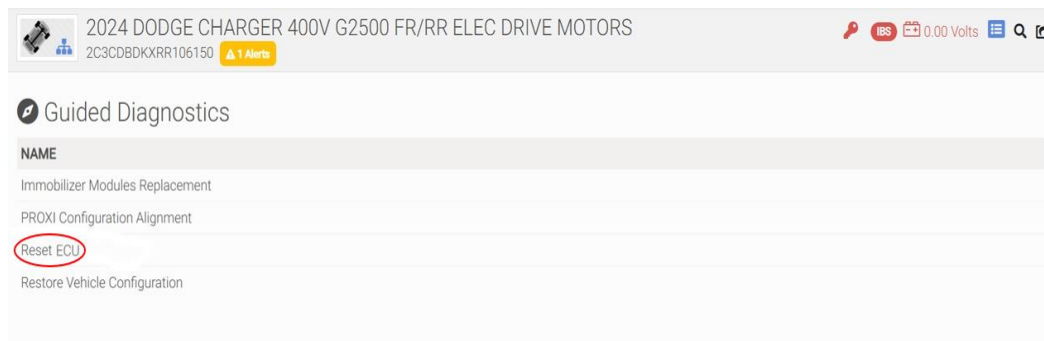
### 3- Select Reset ECU

### **Select ORC and click Continue to reset ORC successfully**

4. Wait 5 seconds
5. Perform 4 Key Ignition Cycles. (OFF 2sec to ON) x4
6. Airbag light will go off 30 seconds after 4th Key Ignition Cycle.
