# TECHNICAL SERVICE BULLETIN

## Illuminated MIL With DTCs P2418:72 And/Or P2450 Stored In The PCM

26-2023

31 March  
2026

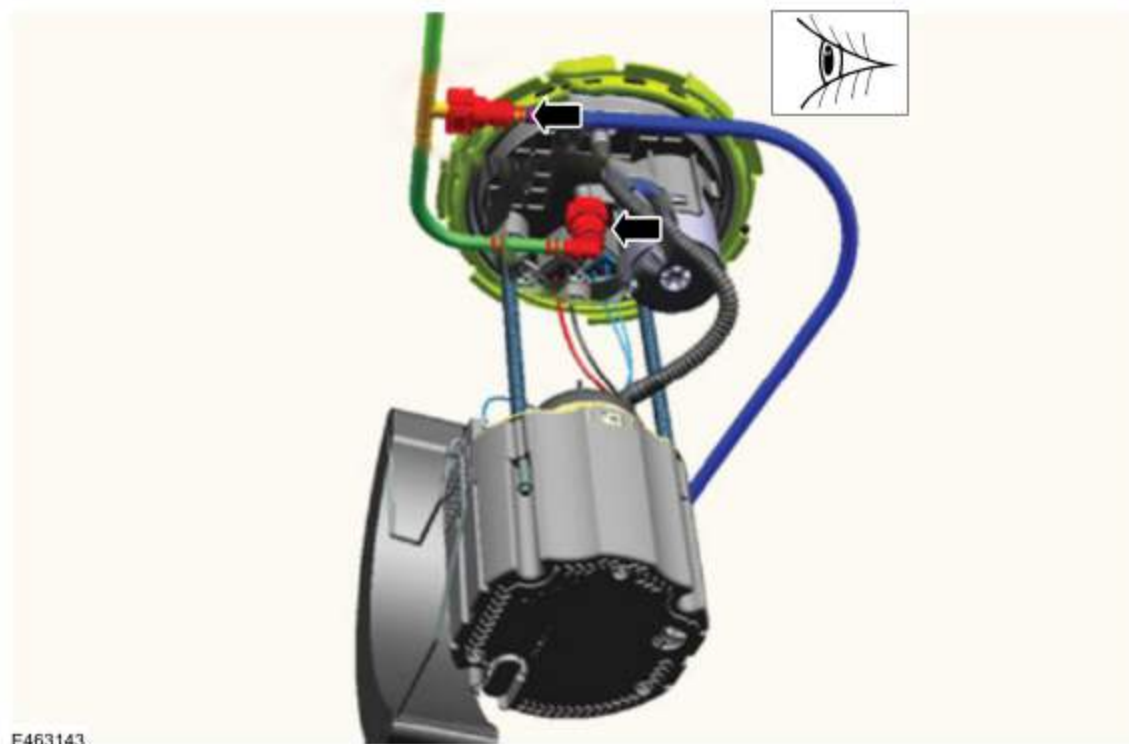
Figure 1

**Issue:** Some vehicles listed in the Model section above may exhibit an illuminated MIL with DTCs P2418:72 and/or P2450 stored in the PCM. This may be due to improperly connected EVAP line connections inside the fuel tank.

3. Remove the fuel pump and sender unit. Refer to the WSM, Section 310-01 Fuel Tank and Lines > Removal and Installation > Fuel Pump and Sender Unit.
4. Inspect the two vent line quick connectors inside the fuel tank (Figure 1) for looseness or damage. Reattach any loose connectors. If the connectors are damaged, replace the fuel tank. Refer to the WSM, Section 310-01 Fuel Tank and Lines > Removal and Installation > Fuel Tank.
