## TECHNICAL SERVICE BULLETIN

### "Steering Assist Fault Service Required" Message In The IPC And Reduced Steering Assist With DTCs U3008:1B And/Or U3009:1B Stored In The PSCM

26-2150

08 April 2026

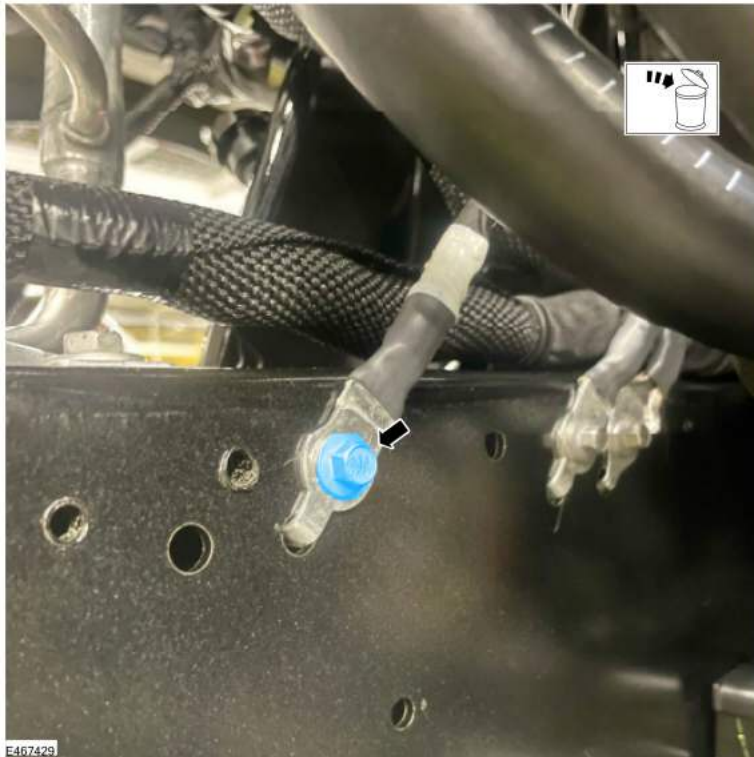
Figure 1 - Vehicles equipped with 2.3L engine

This may be due to the PSCM ground connections.

6. Remove and discard the M6 fastener from ground G104 (Explorer/Police Interceptor) or G116 (Aviator) on the passenger side frame rail. Refer to Wiring Diagram Cell 151 for connection locations. (Figures 1-2)

7. Carefully enlarge the existing holes in the frame rail sheet metal and the harness eyelet by drilling with a 7 mm (9/32 in) drill bit.
8. Reinstall ground G104 (Explorer/Police Interceptor) or G116 (Aviator) using the new self-tapping M8 fastener. Make sure the ground eyelet locating tab is properly aligned with the alignment hole in the frame. Tighten to 71 lb.in (8.0 Nm).

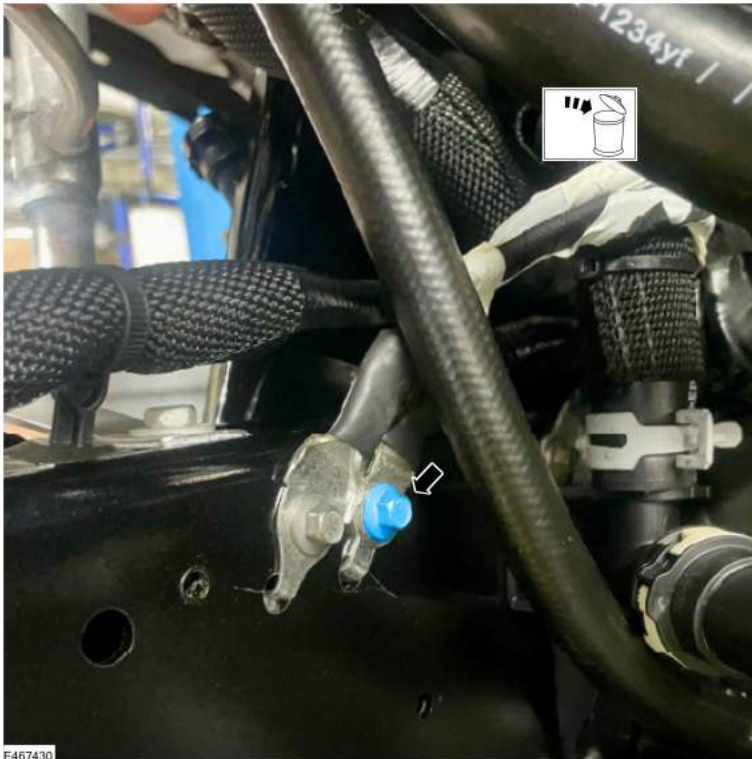
Figure 2 - Vehicles equipped with 3.0L and 3.3L engine

**NOTE:** The position of the ground eyelets shown may vary. The suspect ground is the smaller of the 2 eyelets.
