**Technical Service Bulletin (TSB)**  
**ENGINE – 1.5 GSE T4 MHEV**  
**- Malfunction Indication Light (MIL) P0016**

| REFERENCE: | TSB: 09-011-26<br>GROUP: 09 - Engine | Date: | June 6, 2026 | REVISION: | — |
| CONCERNED VEHICLES: | 2022 - 2025 (BV) Jeep Renegade<br>2022 - 2025 (MV) Jeep Compass<br>This bulletin applies to vehicles equipped with the 1.5L I4 DOHC Turbo MHEV Engine (Sales Code EYP). | | | MARKET SPECIFICATIONS:<br><div><input type="checkbox"/> NA<input type="checkbox"/> MEA</div> <div><input type="checkbox"/> SA<input type="checkbox"/> IAP</div> <div><input checked="" type="checkbox"/> EE<input type="checkbox"/> CH</div><br>NOTE: This bulletin applies to Enlarged Europe markets. | |

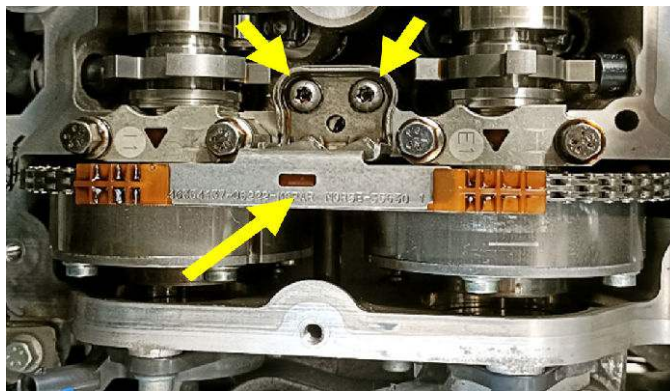
**Fig. 15**

| CAUSE: | Engine timing loss resulting from a tooth jump on the Variable Camshaft Timing (VCT) sprocket | | | | |

23. Remove the flywheel locking pin and the 9 mm diameter pin from the crankshaft pulley.  
24. Lower the vehicle.  
25. Remove the old guide rail (“snubber”) [Fig 15](#).
