## STAR ONLINE PUBLICATION

**Case Number:** S2609000009

**Symptom/Vehicle Issue:** Check Engine Light (CEL) Illuminated with Diagnostic Trouble Code (DTC) P0106 Manifold Absolute Pressure Sensor Performance Setting In The Powertrain Control Module (PCM)

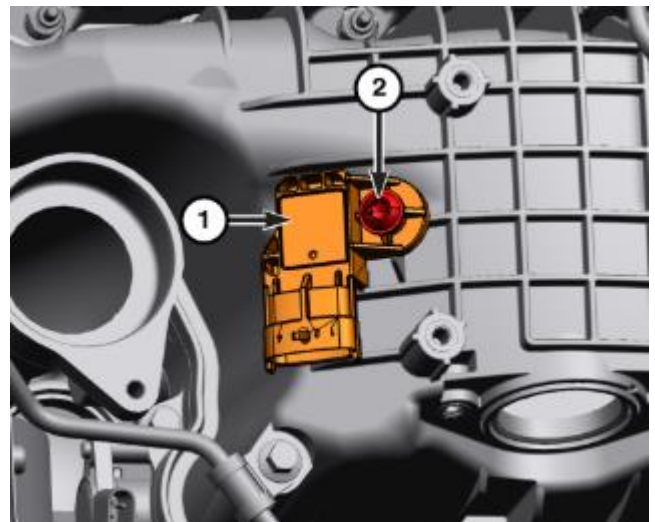
**Owner Complaint/Technician Observation:** Technician may find that DTC P0106 is setting after replacing the intake manifold. At this time the Manifold Absolute Pressure (MAP) sensor that is installed on the new manifold is incorrect and will need to be replaced with the correct MAP sensor for your application or transfer the MAP sensor from the original intake manifold.
