### Check engine light with reduced power with fault codes P300A6D, P300974, P300DFB, or P300DE8

| Topic number | LI09.40-N-079144 |
| Function group | 09.40 - Turbocharger |
| Validity | Model 907 with OM654 |

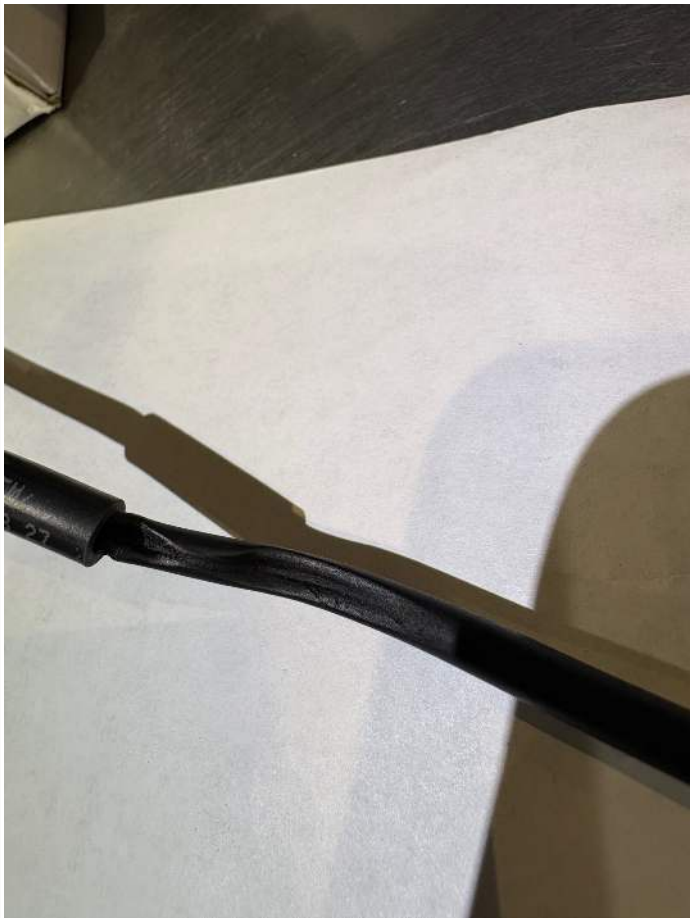
| Attachments | |
|---|---|
| <a href="#">Melted line.jpg</a> | Vacuum Line melted under Low Pressure EGR Cooler |

- Check the vacuum at all vacuum components (such as the Wastegate and Boost Pressure Control Y77, Y100/2) while driving, and compare it to the source vacuum.
- Thoroughly inspect all vacuum lines and connections for signs of wear, cracks, or disconnections.
- Refer to the Attachments for the OM654 Vacuum diagram.
