### Check engine light with reduced power with fault codes P300A6D, P300974, P300DFB, or P300DE8

| Topic number | LI09.40-N-079144 |
| Function group | 09.40 - Turbocharger |
| Validity | Model 907 with OM654 |

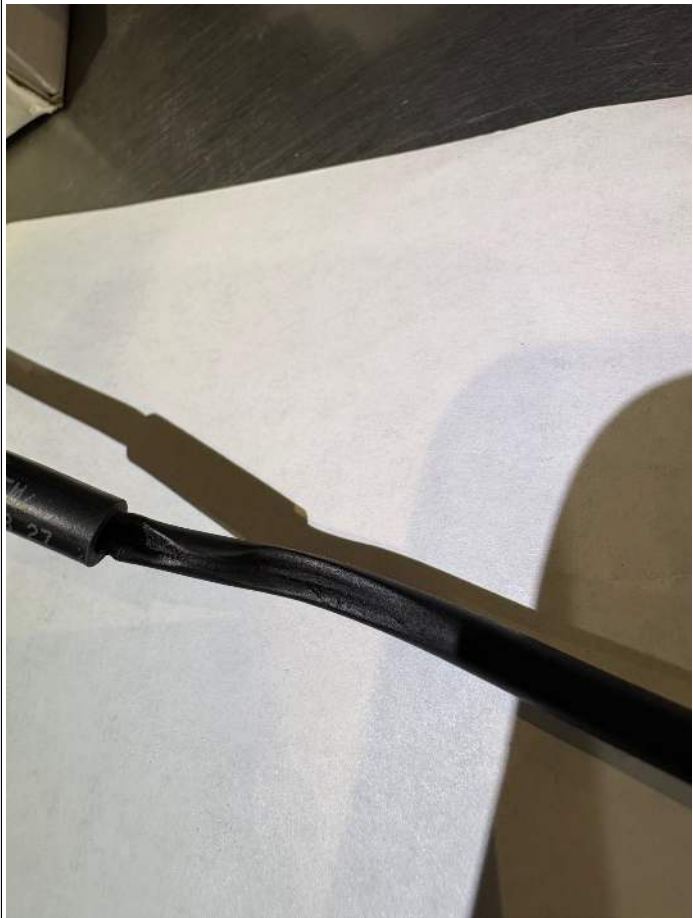
| Attachments | |
|---|---|
| <a href="#">Melted line.jpg</a> | Vacuum Line melted under Low Pressure EGR Cooler |

- Check the vacuum at all vacuum components (such as the Wastegate and Boost Pressure Control Y77, Y100/2) while driving, and compare it to the source vacuum.
- Thoroughly inspect all vacuum lines and connections for signs of wear, cracks, or disconnections.
- Refer to the Attachments for the OM654 Vacuum diagram.

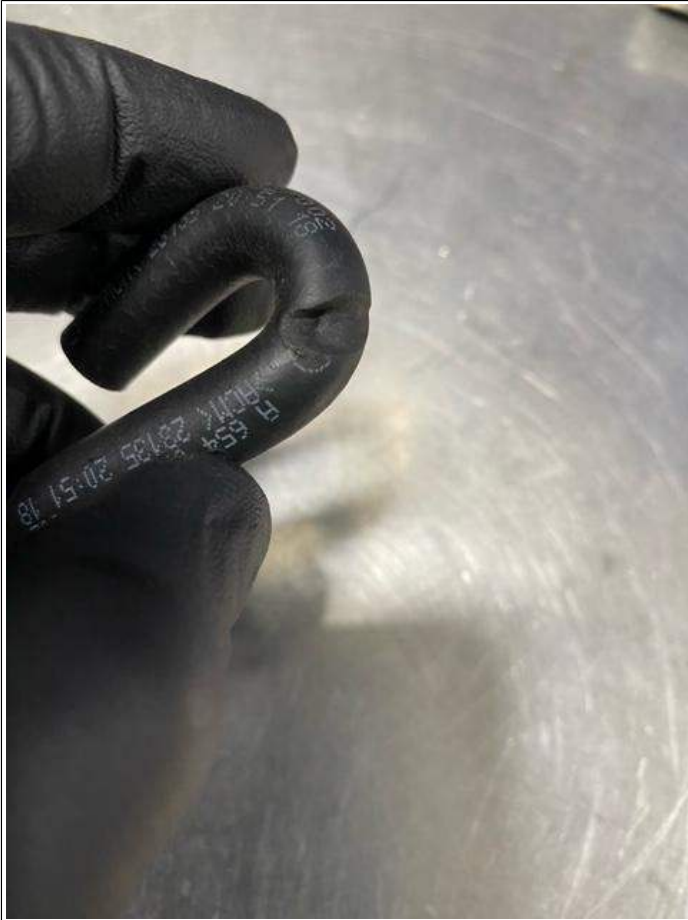
| Attachments | |
|---|---|
| <a href="#">Vacuum Line A654 070 23 32.jpeg</a> | Vacuum Line at High Pressure EGR Cooler Bypass Valve |

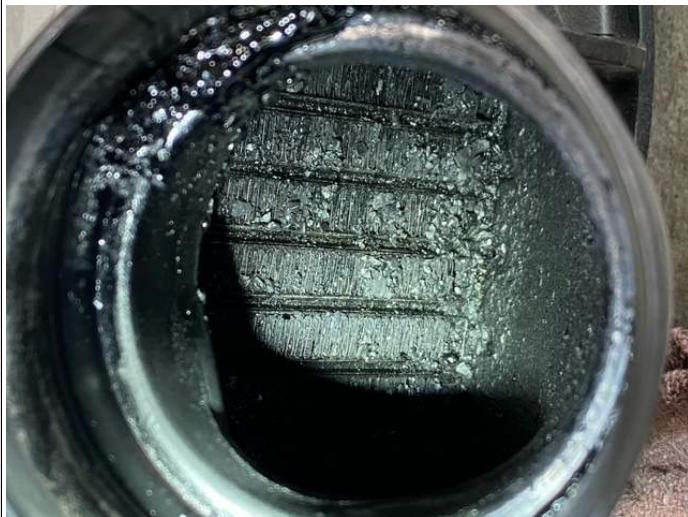
[Inlet Side Of Charge Air Cooler.jpeg](#)

Debris within the Charge Air Cooler

- Check the outlet of the turbocharger (high-pressure side), the charge air pipe at the back of the engine, and the charge air cooler inlet near the firewall for any debris or blockages.
- If oil, debris, or sludge is found in the Charge Air System, Turbocharger Outlet, or Charge Air Cooler Inlet, follow LI09.41-N-080666 for the required repair procedure.
