Check engine light with reduced power –  
P300A6D due to charge air system contamination

| Topic number | LI09.41-N-080666 |
| Function group | 09.41 - Charge air pipe/charge air cooling |
| Validity | Model 907 with OM654 |

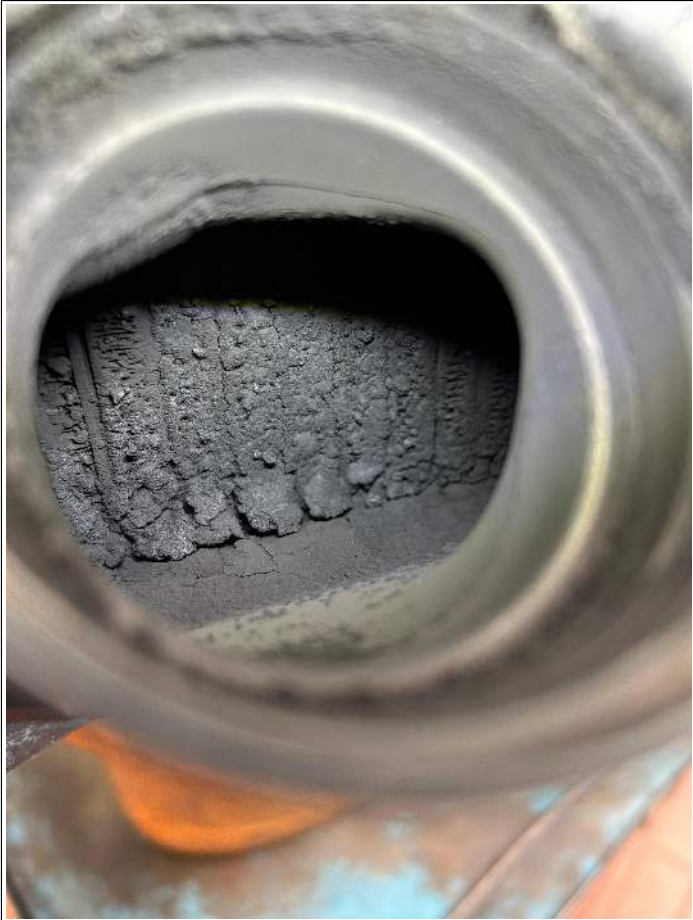
| Attachments | |
|---|---|
| <a href="#">Charge Air Cooler 2.jpg</a> | |

- Oil mist from the crankcase ventilation system can enter the intake tract and deposit within the charge air system
- Under high thermal load and with soot-laden or aged engine oil, these deposits may carbonize
- Carbonized deposits can loosen and accumulate in the charge air cooler and related components
- This can result in partial or complete restriction of the charge air cooler, leading to underboost conditions and fault codes such as P300A6D

- Charge air cooler
- Exhaust turbocharger
- Charge air pipe upstream of the charge air cooler
