# Service Alert

**ELECTRICAL CONCERN AND/OR MULTIPLE DTC'S DUE TO  
AFTERMARKET DEVICE**

**Service Alert No.: SA-041/26**

**Last Issued : 06/18/2026**

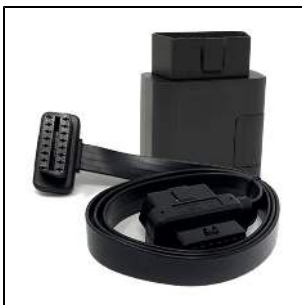
- Battery discharge. The device may disrupt the CAN system battery saver mode.
- IDS/MMDS will not communicate with the vehicle due to poor DLC-2 connection. The aftermarket device may cause DLC-2 female terminals to spread open.
- DTCs
  - B1041:54 - ADAPTIVE FRONT LIGHTING SYSTEM (AFS) CONTROL MODULE
  - B108E:04 - CENTER DISPLAY INTERNAL MALFUNCTION
  - C0061:54 - DSC HU/CM
  - C1001:92 - FORWARD SENSING CAMERA (FSC)
  - C1001:97 - FORWARD SENSING CAMERA (FSC)
  - U300A:62 - ELECTRIC PARKING BRAKE (EPB)
  - U3004:17 - ACC RELAY CIRCUIT MALFUNCTION
  - U0415:00 - MAZDA RADAR CRUISE CONTROL (MRCC)/SMART BRAKE SUPPORT (SBS)
  - U0420:00 - MAZDA RADAR CRUISE CONTROL (MRCC)/SMART BRAKE SUPPORT (SBS)
  - Multiple DTC's (U0XXX:00 COMMUNICATION ERROR)

**NOTE:** Some aftermarket devices may include a pig-tail connector or passthrough attached to the OBD-II port. Be sure to check for any extensions, splitters, or other port adapters (see example image below).

- If an aftermarket device is found connected to DLC-2, take a photo and attach it to the RO. Advise the customer to remove it.
- If you determine that no aftermarket devices have been installed, continue with normal MGSS diagnosis.

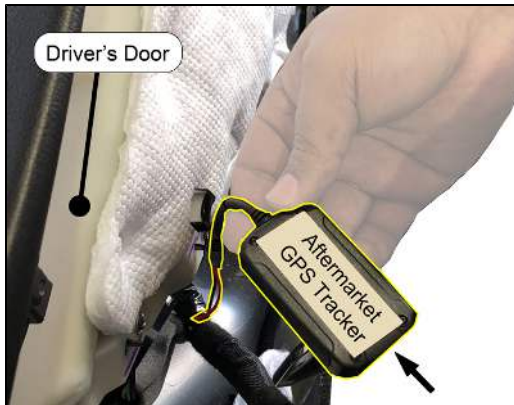
Below are examples of concerns due to an aftermarket GPS tracking device wired to the power window main switch:

- Engine no start
- Battery discharge
- Main relay buzzing

- If the customer's concern(s) are verified to be caused by any aftermarket device as described in the examples above, take a photo of the device and include it with the RO. The customer should also be advised to remove the device.
- If it is determined that no aftermarket devices have been installed, continue with normal diagnosis on MGSS. Please contact [Technical Hotline](#) for repeat visits.

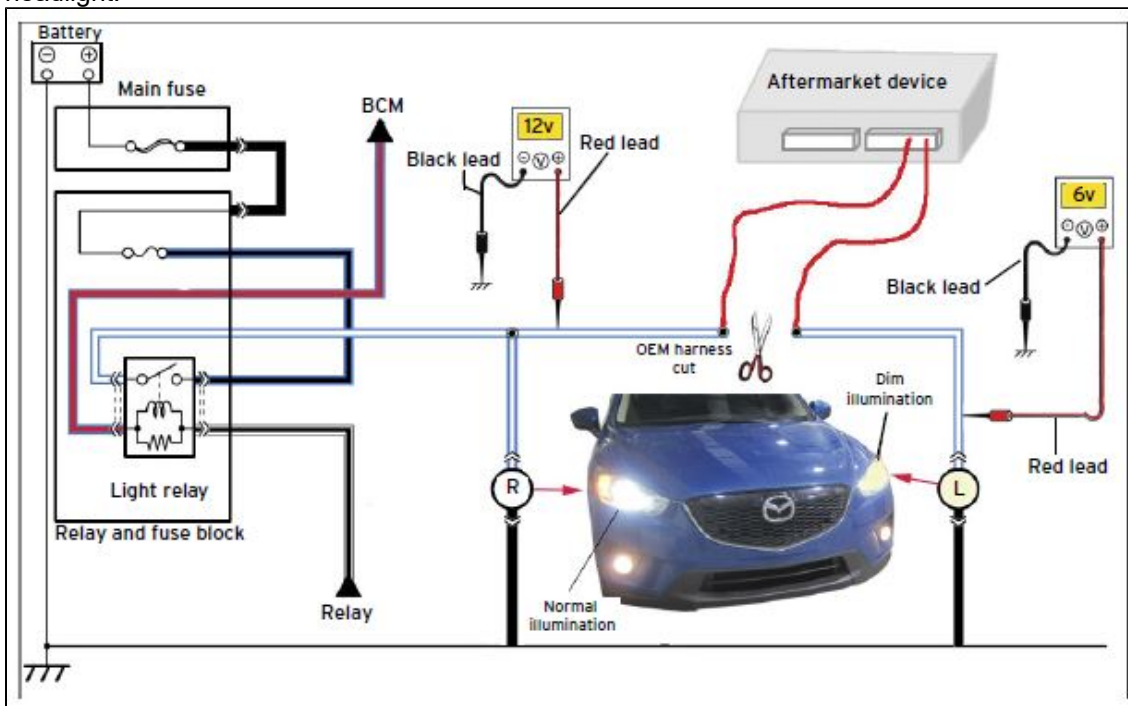
Below is an example of a dim headlight. The aftermarket device changed the headlight circuit resistance, causing a dim headlight.

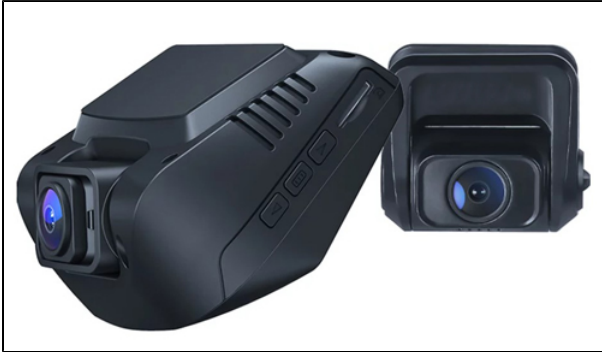
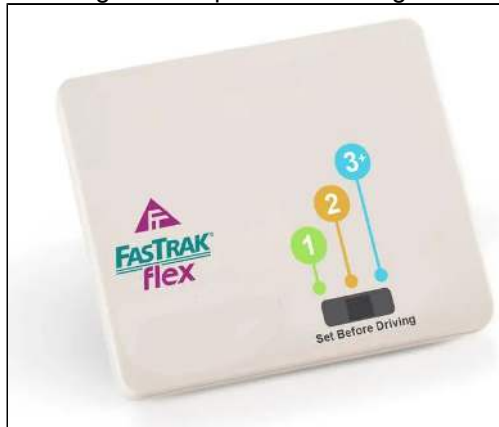
DTC B119F:01 (TEL antenna No.1 malfunction) stored. This may be caused by an aftermarket dash cam, radar detector and/or FasTrak device.

The aftermarket device may cause electrical noise disturbing the reception of GPS signals.

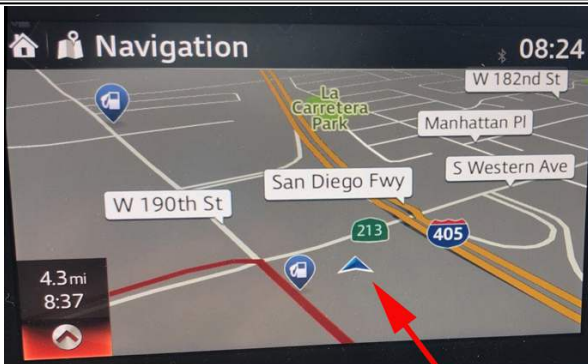
Navigation display map shows incorrect GPS location (A). This may be caused by over-sized wheels/tires. Confirm correct wheel/tire size according to the tire label.

Navi Map Shows Incorrect GPS position (A)

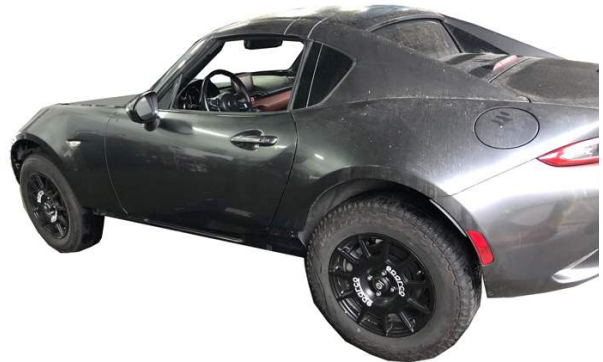
Possible oversized wheels/tires

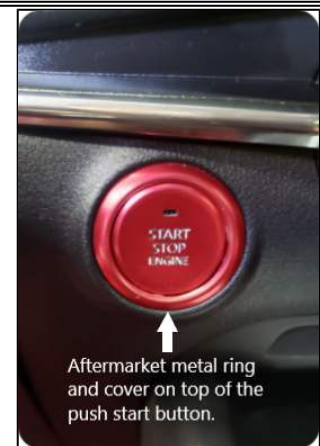
When programming a key or installing a Genuine Mazda Accessory Remote Engine Start system, you may encounter programming difficulty. This may be caused by a customer installed aftermarket decorative trim and/or cover on the START/STOP ENGINE button. The aftermarket accessory may create electrical interference, which may interfere with programming.
