# Service Bulletin

## PRELIMINARY INFORMATION

**Subject:** EBCM Wheel Speed Sensor Diagnostic Aid for ABS Message -Click Or Ratchet Noise- Service Traction Message - Service Stabilitrak Message - Service Steering Message

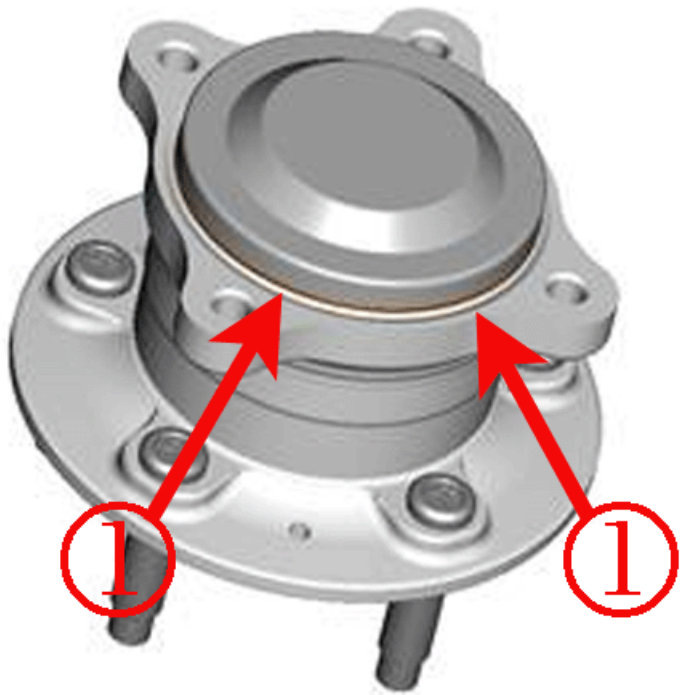
(1.) Capped Wheel Bearing

**Note:** NOTE: THIS INFORMATION IS NOT APPLICABLE TO CAPPED WHEEL BEARINGS.

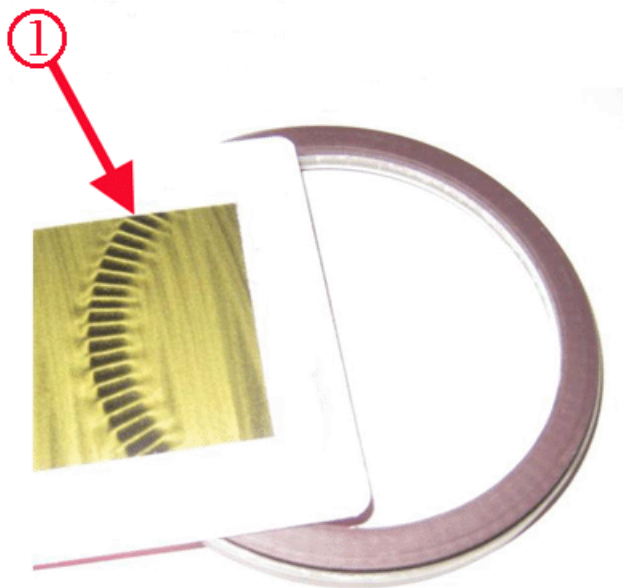
### (1.) Wheel Speed Sensor

Magnetic Encoder Ring - North and South Poles are shown

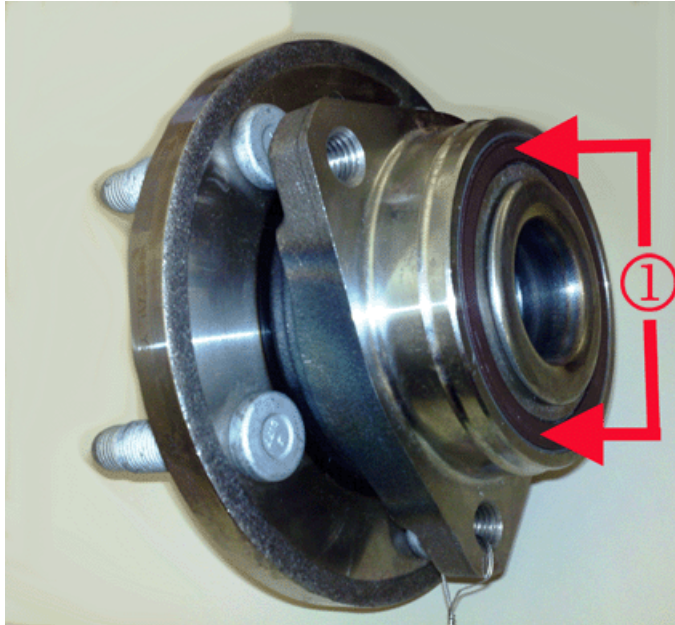
### (1.) Magnetic Encoder Ring

Some new model vehicles today have begun to use a different type of wheel speed sensor encoder ring or tone wheel. Instead of a traditional mechanical type tooth tone wheel, the wheel speed sensor tone wheel is now made of a magnetized nitrile rubber ring, typically brown in color. This magnetic encoder consists of multiple North and South Pole pairs surrounding the outer circumference. When this magnetic encoder ring rotates and passes by the wheel speed sensor head; it generates a sign wave in the wheel speed sensor. The wheel speed sensor converts an analog signal to a digital square wave, and typical digital signal values switch between 7mA (Low) and 14mA (High) DC current.

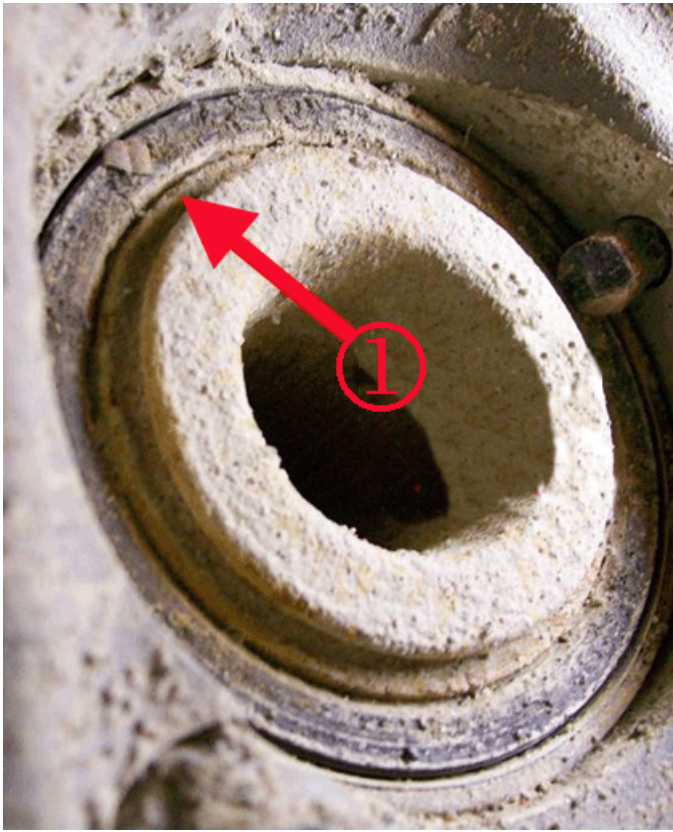
BEFORE CLEANING

These conditions may be caused by single or multiple pieces of ferrous metallic debris stuck to the wheel speed sensor magnetic encoder ring. This magnetic encoder ring is now part of the inboard bearing hub assembly.

(1.) Sample Debris

1. Based on the specific EBCM module Wheel Speed Sensor DTC code; inspect the appropriate corner magnetic encoder ring for possible debris.
  - C0035 Left Front Corner
  - C0040 Right Front Corner
  - C0045 Left Rear Corner
  - C0050 Right Rear Corner

2. If debris is found, perform the following cleaning recommendations.

- 2.1. Gently using a dry nylon soft bristle brush, remove the foreign debris off the magnetic encoder ring. If debris was removed, proceed to step 3.
- 2.2. If debris still remains, wash the encoder ring using a mild soap detergent and wipe dry.
