# Service Bulletin

**Subject:** Service Stability Traction ABS Rear Wheel Speed DTC Or Chassis Expansion Bus Communication Fault

**Models:** 2010 - 2012 Chevrolet Equinox

2010 - 2012 GMC Terrain

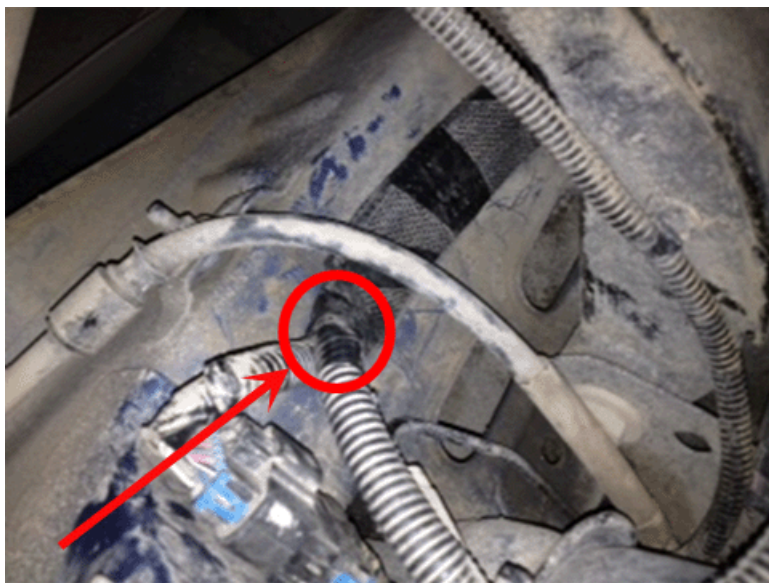
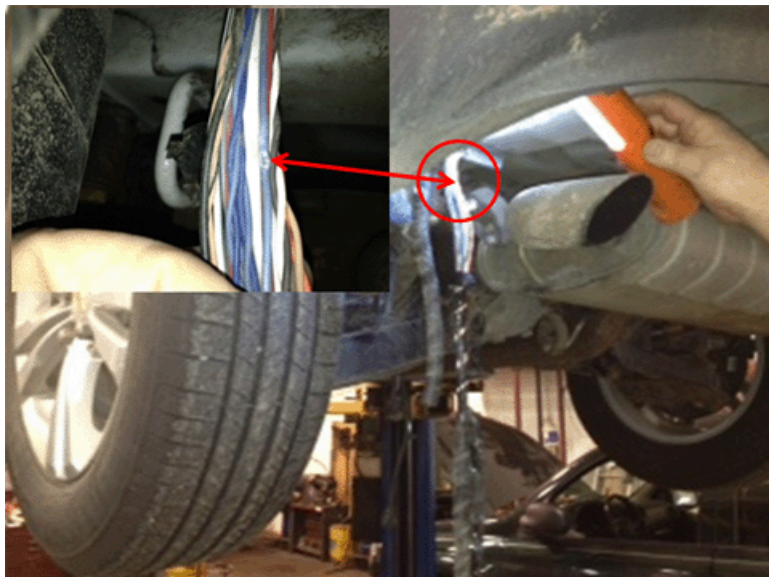
Several conditions and symptoms have been found to be related to a wire harness at the left rear under vehicle. Inspect the wire harness insulation within 1 inch of the X411 before and after connector. It may be necessary to remove the tape and conduit from the wire harness for inspection upstream from the X411 connector. Some Issues have been found with circuits 6105 and 6106 for chassis bus wires and serial enable circuit 5986 and 120 ohm opens in 2500 and 2501 or 6106 and 6106. Other circuits 884, 885, 882, and 883 when related to rear wheel speed sensor codes C0045 or C0050. During inspection you may notice a discoloration in insulation in one spot of the wire. If you pull the wire near that area the insulation will break exposing the broken wire. Repair the circuit to complete the procedure.

**Note:** Wire broken within the insulation has also been found high up in the harness X411. Reference the following photos:
