# Service Bulletin

## PRELIMINARY INFORMATION

**Subject:** EBCM Wheel Speed Sensor Diagnostic Aid for ABS Message - Click Or Ratchet Noise - Service Traction Message - Service Stabilitrak Message

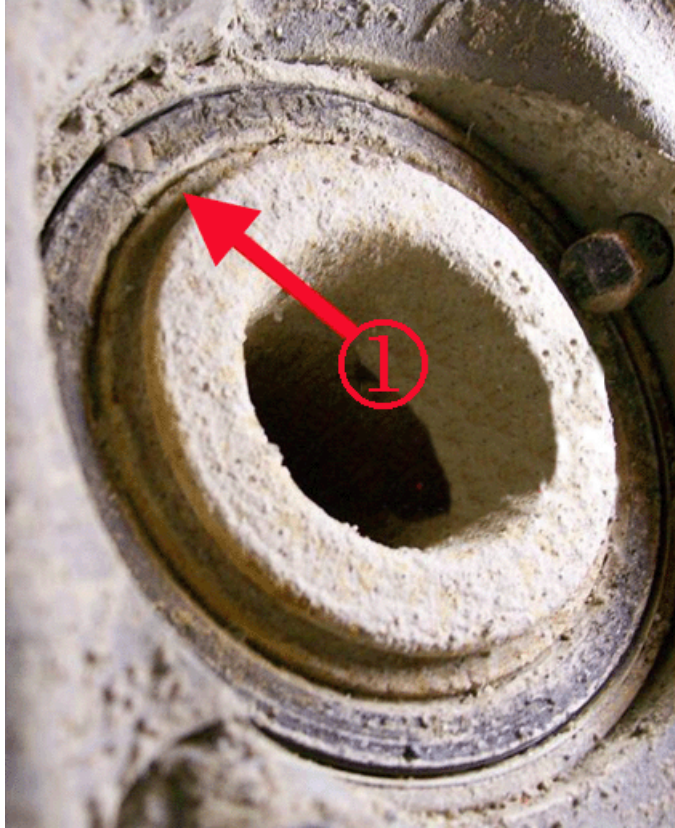
#### BEFORE CLEANING

These conditions may be caused by single or multiple pieces of ferrous metallic debris stuck to the wheel speed sensor magnetic encoder ring. This magnetic encoder ring is now part of the inboard bearing hub assembly.

#### 1. Sample Debris

1. Based on the specific EBCM module Wheel Speed Sensor DTC code; inspect the appropriate corner magnetic encoder ring for possible debris.
  - C0035 Left Front Corner
  - C0040 Right Front Corner
  - C0045 Left Rear Corner
  - C0050 Right Rear Corner

2. If debris is found, perform the following cleaning recommendations.

- 2.1. Gently using a dry nylon soft bristle brush, remove the foreign debris off the magnetic encoder ring. If debris was removed, proceed to step 3.
- 2.2. If debris still remains, wash the encoder ring using a mild soap detergent and wipe dry.
