# Service Bulletin

**Subject:** Navigation or Radio Display Blank Or Flashing DTC B1265 B1288 Or B1289

**Models:** 2007-2013 Cadillac Escalade Models

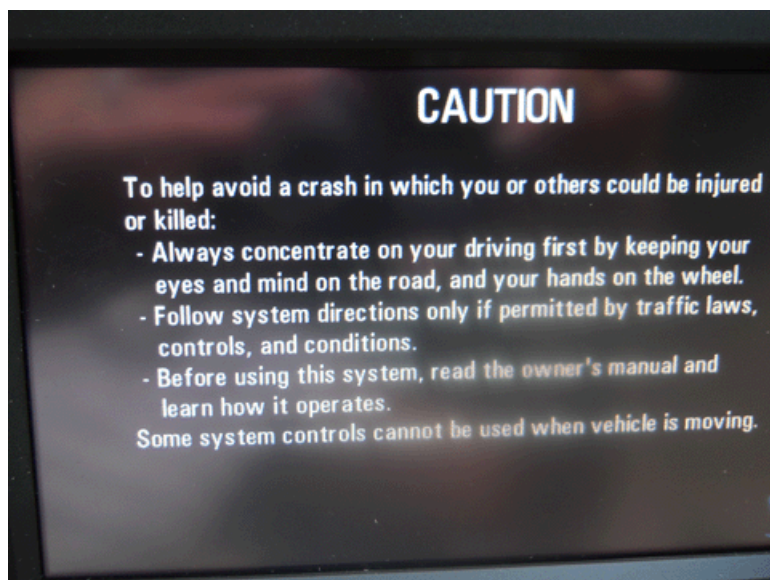
- Navigation or radio screen is blank or flashes on and off
- No sound from speakers
- Rear DVD screen inoperative
- DTC B1265, B1288 Or B1289
- Navigation disclaimer message intermittently will be displayed (see below)

This condition may be caused by the remote enable signal wire circuit 7066 being shorted to ground. This remote enable signal comes from the radio and feeds the Amplifier (except vehicles with RPO Y91 or any 2009 and later Chevrolet Utility equipped with RPO STZ), the antenna module (utilities only), and the rear video display (with RPO U42).

**Note:** When the remote enable signal wire (Circuit 7066) is first shorted to ground, the navigation screen or radio display may start to flash. If the wire remains shorted for more than 2 minutes, the navigation or radio display goes blank. The radio's current limiting logic will not re-enable the output on the entertainment remote enable circuit until after the radio performs a full power-down. It may be necessary to wait 5 minutes with the key OFF and retained accessory power OFF for the radio to re-enable this output.

If you experience this concern, check for a short to ground on the remote enable signal wire (Circuit 7066) and repair and re-route the circuit as needed. The most common area of concern is a shorted wiring harness near the rear DVD display screen under the headliner.
