# Service Bulletin

**Subject:** Suspension DTCs C0696 Or C0711, Incorrect Trim Height, Compressor Inlet Hose Loose, Or Compressor Self Test Inoperative

**Models:** 2001-2013 Cadillac Escalade, Escalade ESV, Escalade EXT  
2001-2013 Chevrolet Avalanche, Tahoe, Suburban LD  
2001-2013 GMC Yukon, Yukon XL LD, Yukon Denali, Yukon Denali XL  
With RPO Z55 or Z95

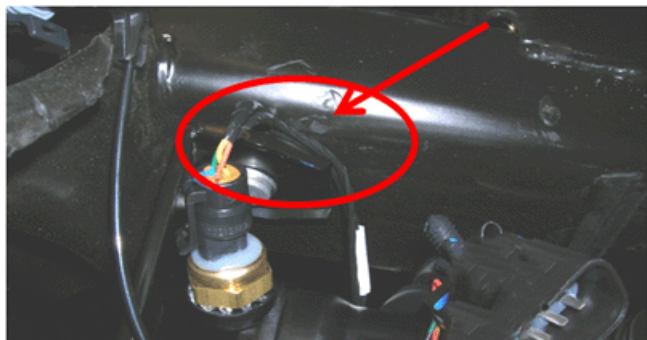
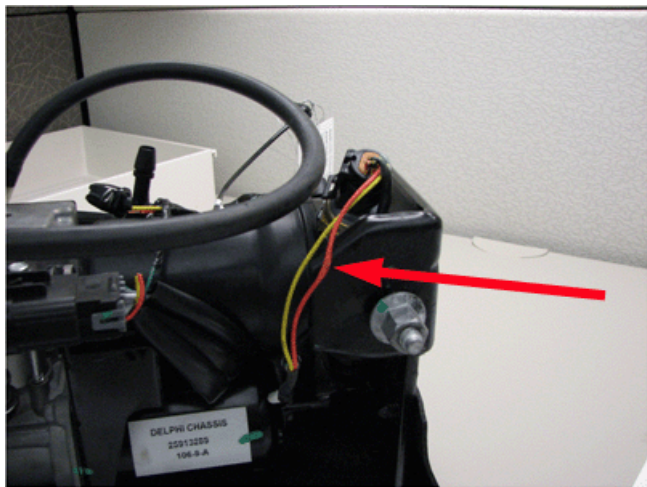
Some customers of 2009 or prior vehicles, may comment of a Service Suspension System message on the DIC and the rear suspension ride height is incorrect. When checking for DTCs the Electronic Suspension Control (ESC) module will have DTC C0696 or C0711 set. This concern could be caused by the wiring to the automatic level control (ALC) pressure sensor being shorted to ground, as shown below.

**Note:** The air compressor assembly may need to be removed from the vehicle to determine if the wiring is possibly pinched between the compressor assembly and frame.

**Note:** DO NOT replace the complete air compressor assembly for this concern.

Repair any damaged or shorted circuits and then reposition the wiring so it does not get damaged again during the compressor assembly installation.

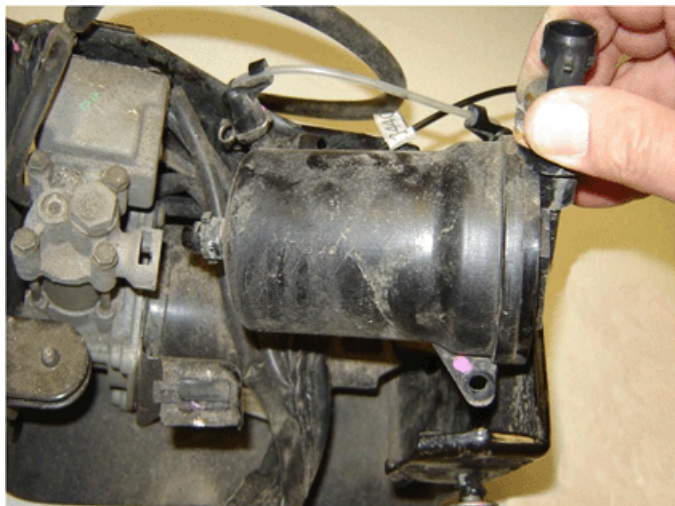
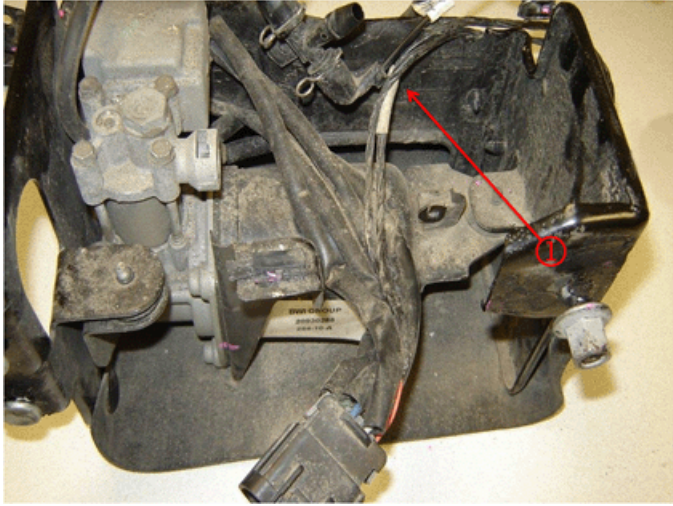
Some customers may comment of a Service Suspension System message on the DIC and may also comment that the rear suspension ride height may be low under a heavy payload. When checking for DTCs the Electronic Suspension Control (ESC) module will have DTC C0711 set. This concern may be caused by an internal fault in the automatic level control (ALC) pressure sensor. This may occur due to moisture getting into the sensor.

**Note:** Ensure the sensor wiring (1) is routed carefully under and around the air filter, dryer, and sensor assembly to prevent damage along the vehicle frame

during compressor assembly installation.

Follow diagnostic procedures to determine if the sensor needs to be replaced. The sensor is no longer serviced separately. For sensor replacement, install a complete air filter, dryer, and sensor assembly. Installing this complete assembly will provide a better repair than replacing the sensor only. Refer to SI procedure, Automatic Level Control Air Compressor Filter Replacement.

**Note:** An improved sensor design was implemented beginning with vehicles built in May, 2012. Vehicles built before May, 2012, will require a jumper harness for the updated sensor design. The jumper harness is included with complete air filter, dryer, and sensor assembly, PN 22964558. Vehicles built in May, 2012 and later do not require the jumper harness, and use PN 22941807.

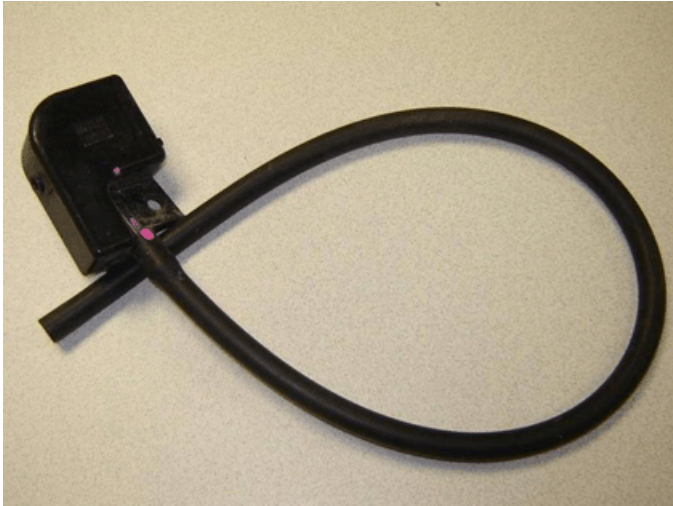
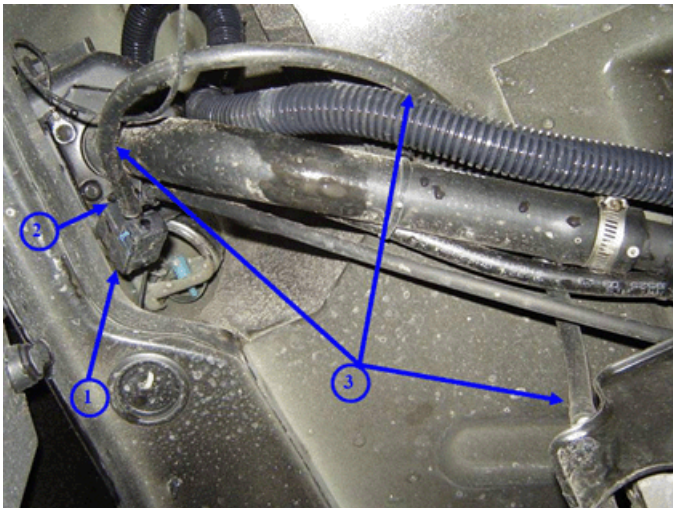
Some customers may comment of a loose hose hanging down in the left rear of the vehicle. Upon inspection it may be determined that the hose is damaged or has become disconnected from the air inlet filter of the auto leveling suspension air compressor.

Replace the auto leveling compressor air inlet filter and hose assembly (PN 22197160), shown below.

1. Raise and support the vehicle. Refer to Vehicle Lifting and Jacking in SI.
2. Release the air compressor air inlet filter (1) from the retainer (2) securing the rear axle vent hose and compressor air inlet to the fuel fill pipe assembly.
3. Remove the remaining air inlet hose (3) from the air compressor.
4. Install the new air inlet filter and hose assembly, PN 22197160. Ensure the air inlet hose (3) is routed as shown.
